BAM Information Summary

Seaside Exposure of Sensor Samples in the North Sea

within the research project “Development of standards for fibre optic sensors under offshore-typical conditions” (BAM-VH 8138)

Report period: June 2012 to November 2013

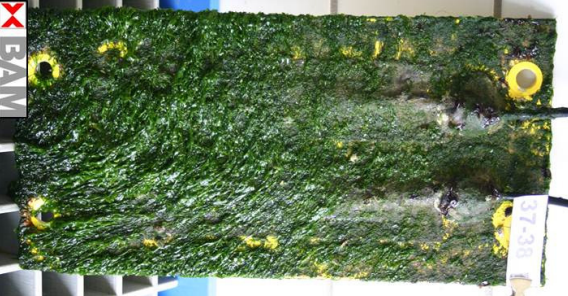
Tidal zone	Plate	Picture
Upper	37/38

It was observed that the biological fouling continued in a strong way. The plates and the sensor installations were affected by growth of algae and barnacles. Especially plate 33/34 was significantly overgrown by barnacles.

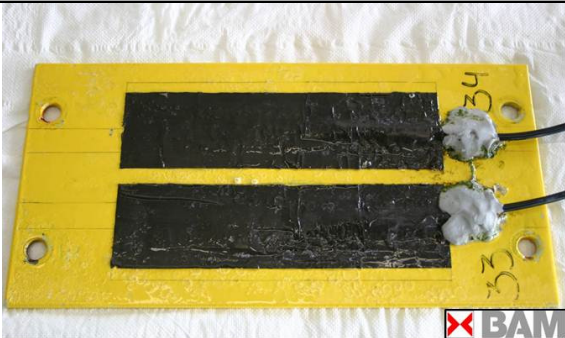
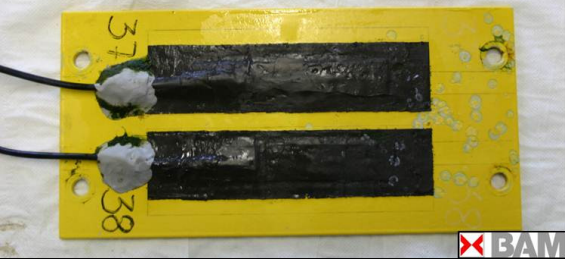
The ice growth and the low temperatures in the North Sea during the winter period 2012/2013 lead to the death of algae and barnacles and “washed” the sensor plates from biological fouling. At the locations where the barnacles were fixed, the first layer of painting was damaged. However, corrosion attack was not observed. Plate 35/36 could not be investigated. The rack with sensor plates that was installed in the lower tidal zone in December 2012 was not found in its place in April 2013. It is assumed that it was ripped or pressed out of the rack suspension probably due to severe ice growth and ice floes pressing against the racks in the winter. This rack, mounted with plate 35/36 finally was found by divers on the ocean ground nearby in summer 2013. The damaged rack was then placed again on top of the rack suspension until the end of November 2013. The two remaining plates of the measurement campaign in April 2013 were changed in place and mounted back again in the racks and exposed to the North Sea. Plate 33/34 was placed in the middle tidal zone and plate 37/38 was placed in the lower tidal zone.

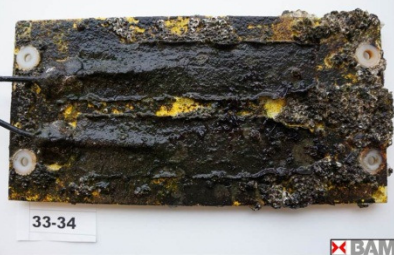
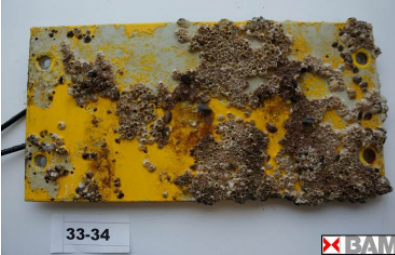
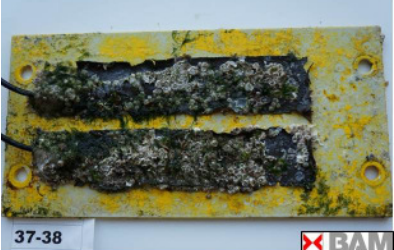
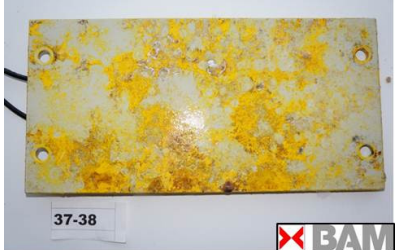
At the end of November 2013, the plates were taken out of the North Sea. They were visually inspected as shown in the following table and a third, final measurement campaign was carried out. Again, a strong biological growth of algae and barnacles was observed during summer 2013. The black protection layer of the plates 33/34 and 37/38 was attacked by barnacles. The edges of this protection layer already ripped and started to peel off. Barnacles were creeping under the protection layer. No significant corrosion was observed.

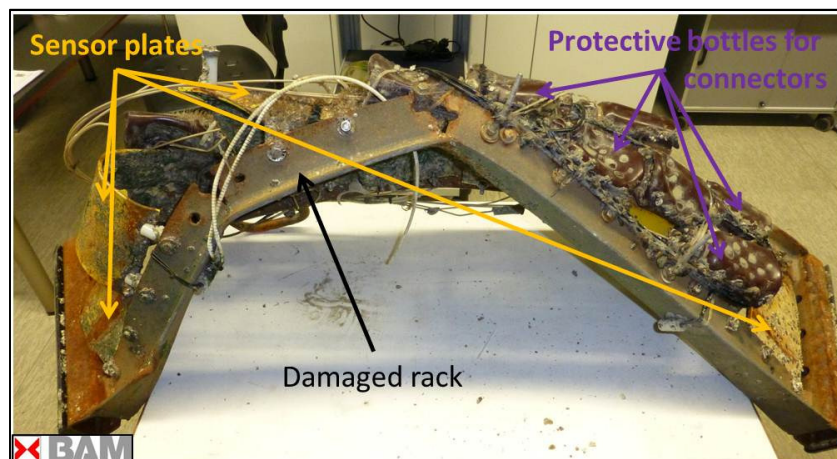
Fig. 3: Side view of the damaged rack with sensor plates.

Plate 35/36 was also recovered from the damaged rack in November 2013. Fig. 3 shows the damages from ice floes of the complete rack. Plate 35/36 was plastically deformed, as shown in Fig. 4. The protective layer of the sensors was significantly damaged. Corrosion was observed in the area of the sensors. A measurement in a four-point bending machine was no longer possible for plate 35/36. The back-reflected spectrum was analysed at room temperature.

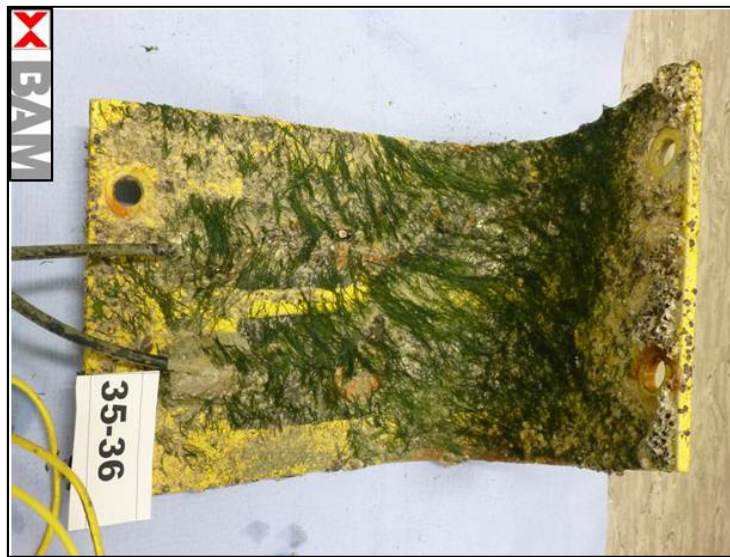
Fig. 4: Plate 35/36 after removal from the damaged rack.

Sample plate 35/36 was lost due to the severe winter and ice floe in 2012/2013. The sample plate could not be tested in the four-point-bending machine because it was plastically deformed. A comparison of the spectra in the unloaded case shows that the sensor of measurement point 35 is still operating. It has suffered a negative wavelength shift due to the compression of the sensor on the plastically deformed plate.

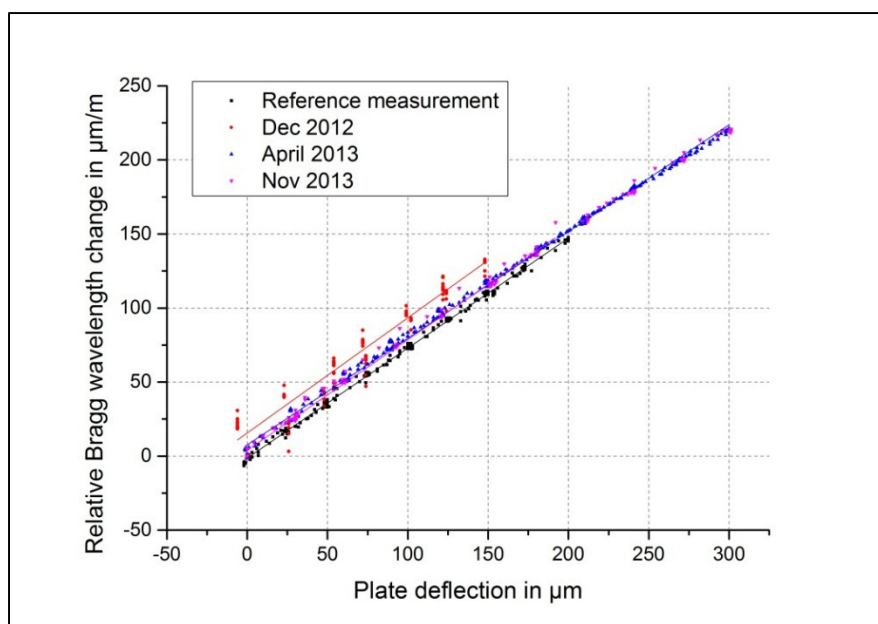
Measurement point 33:

It can be seen, that measurement point 33 shows a linear relation between the change in relative Bragg wavelength and the deflection of the plate during four-point-bending over the total duration of the test. The relation (slope) between plate deflection and relative Bragg wavelength change is defined as the sensitivity coefficient γ , as shown in Table 1.

The deviation of the sensitivity coefficient from the reference measurement is within a margin of 5 %. This deviation includes uncertainties from the measurement object like slight deformation of the sample plates due to ice floes and from the four-point-bending test itself (no strain reference, no way to define a certain deflection).

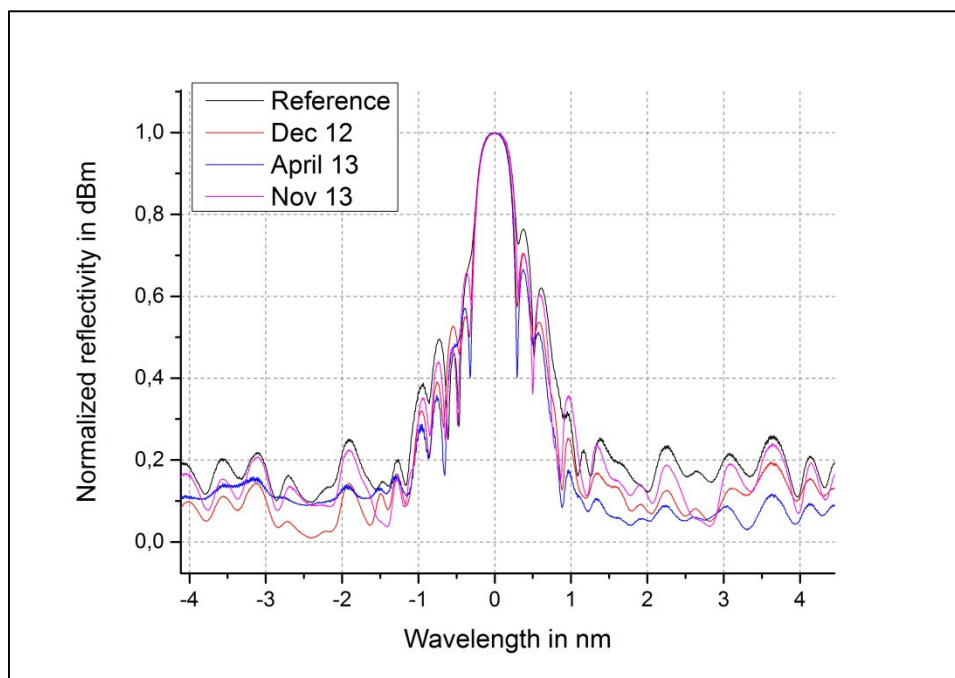
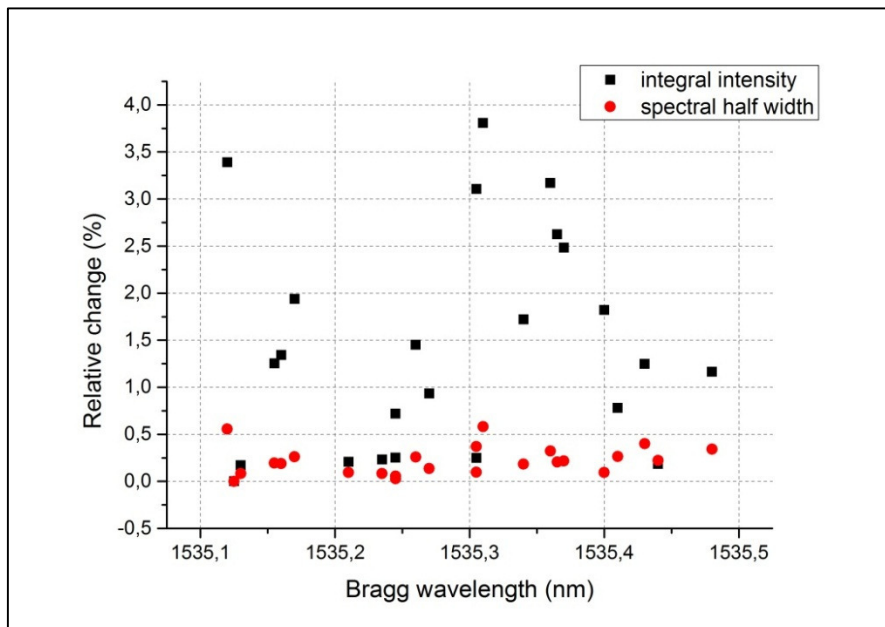
Taking a look at the spectral response signal, it can be seen that the spectrum preserves its original form in the unloaded case of the sample plate.

Characteristic parameters that describe the spectrum deformation are the spectral half width δ and the integral intensity S . A significant change in these parameters during loading may indicate a non-homogeneous strain field acting on the sensor and/or partial debonding or interface failure. During loading, the change in spectral half width was below 1 % and the change in integral intensity was below 4 %. These deviations are considered to be acceptable. Therefore, measurement point 33 was not affected by delamination.

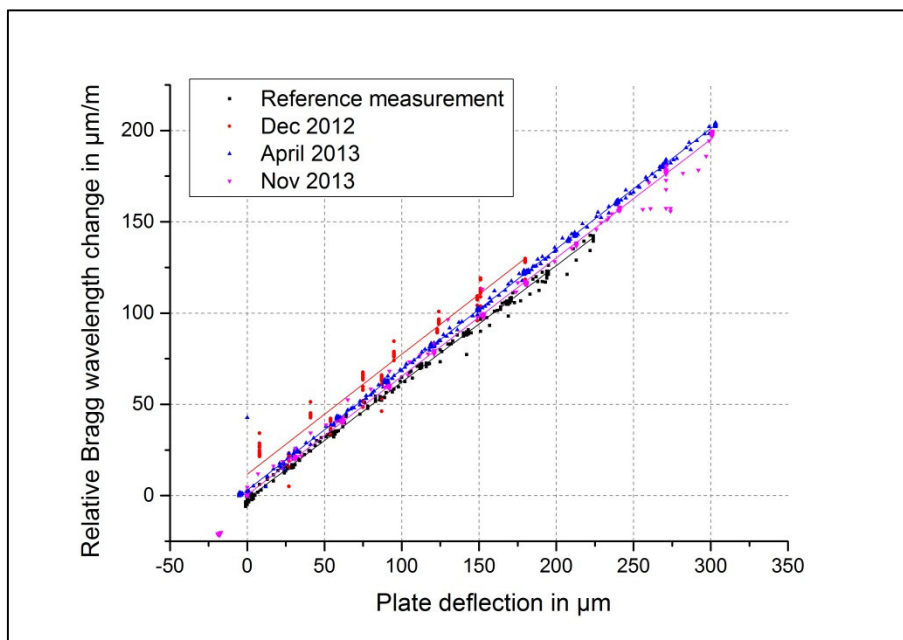
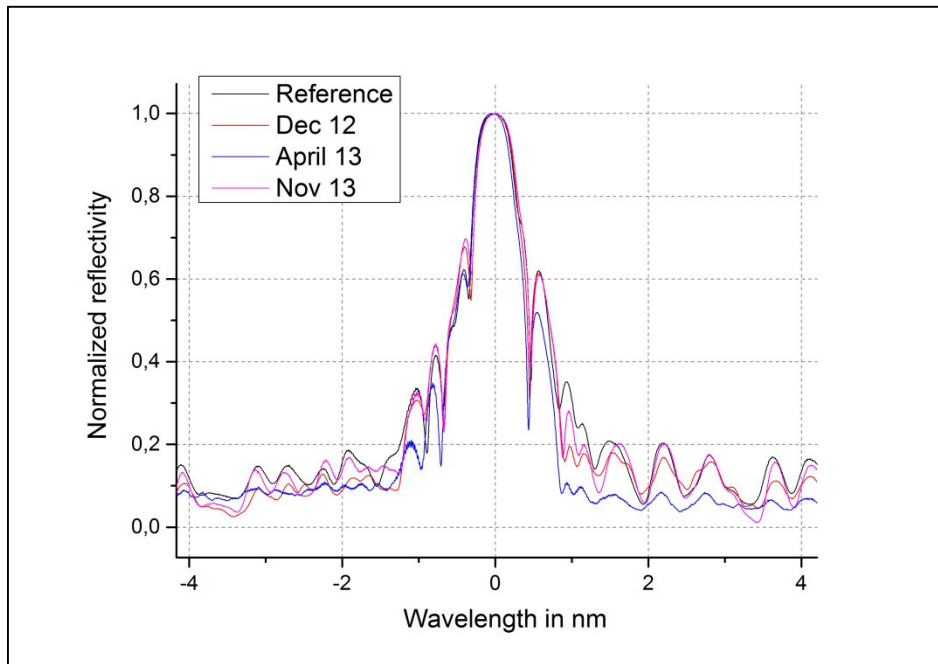
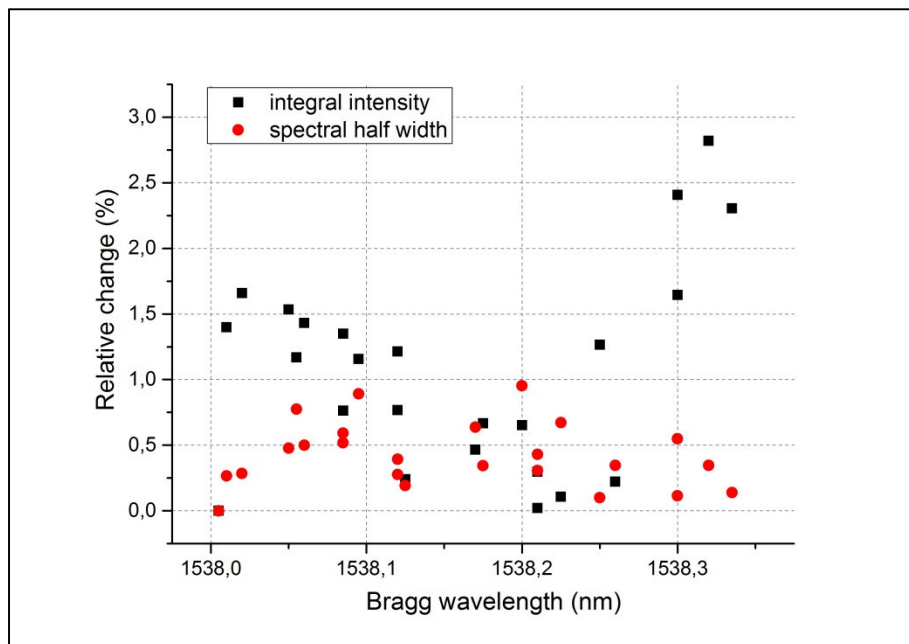
Measurement point 34:

The deviation of the sensitivity is within a margin of 5 %. The measurement point shows linear behaviour due to the plate deflection.

During loading, the change in spectral half width was below 1 % and the change in integral intensity was below 3 %. These deviations are considered to be acceptable. Therefore, measurement point 34 was not affected by delamination.

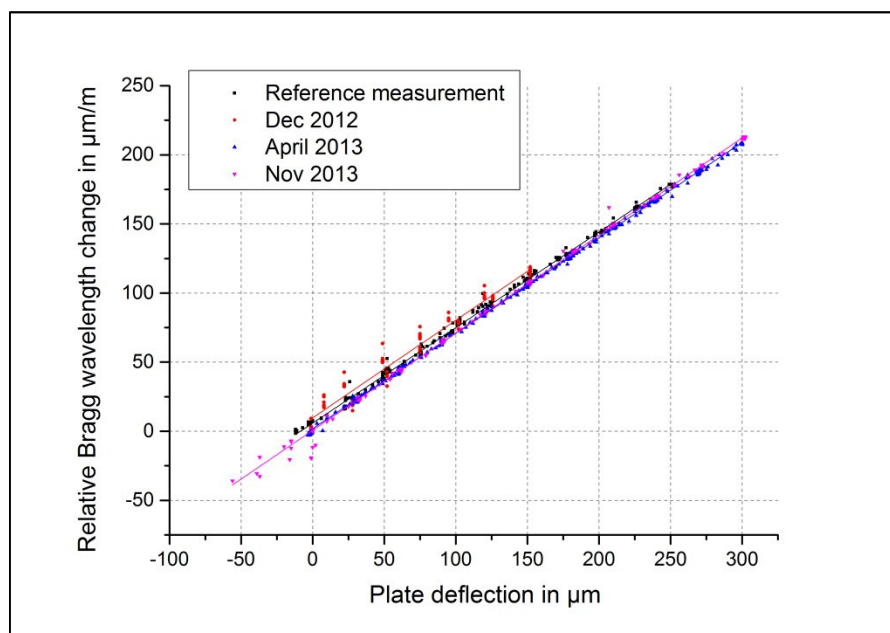
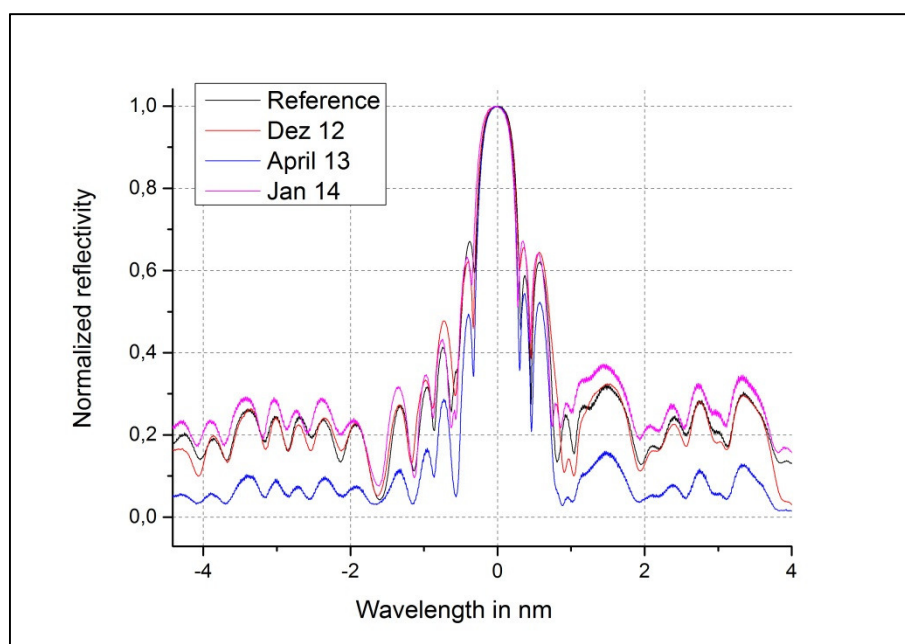
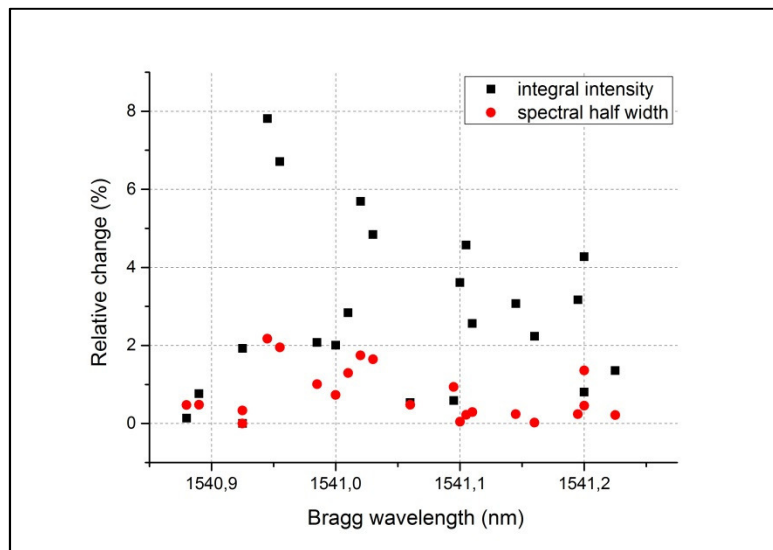
Measurement point 37:

The deviation of the sensitivity is within a margin of 5 %. The measurement point shows linear behaviour due to the plate deflection.

During loading, the change in spectral half width was around 2 % and the change in integral intensity was below 8 %.

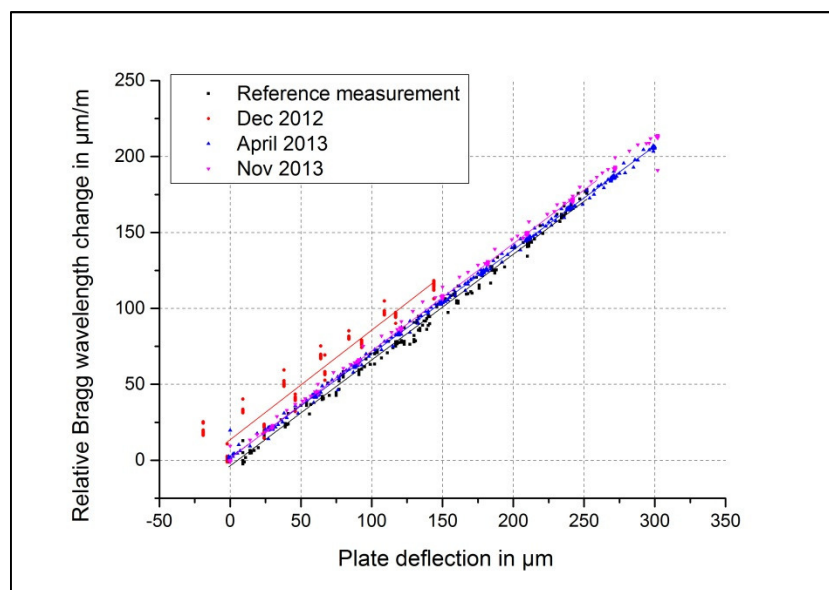
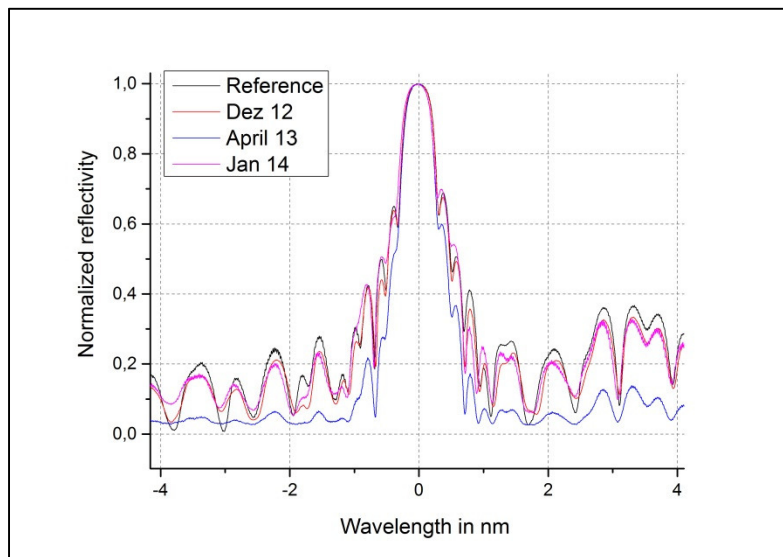
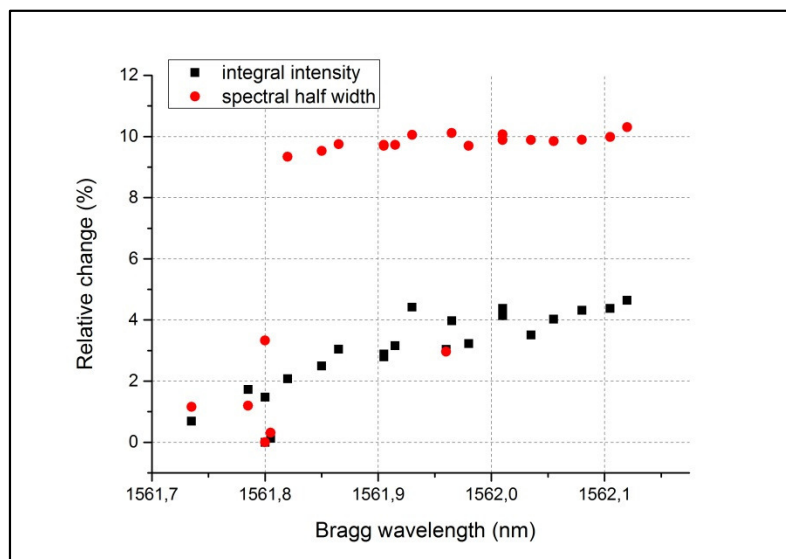
Measurement point 38:

The deviation of the sensitivity is within a margin of 5 %. The measurement point shows linear behaviour due to the plate deflection.

In the following figure, the change in spectral half width and integral intensity of the spectra are shown during loading. The integral intensity increases constantly while the spectral half width changes rapidly after the first three load steps and then keeps on almost constant. It is assumed, that the sample plate itself is not straight but slightly plastically deformed. When loading in the 4-point-bending machine at a certain load, the plate has been straightened and the change in spectral width keeps constant around 10 %.

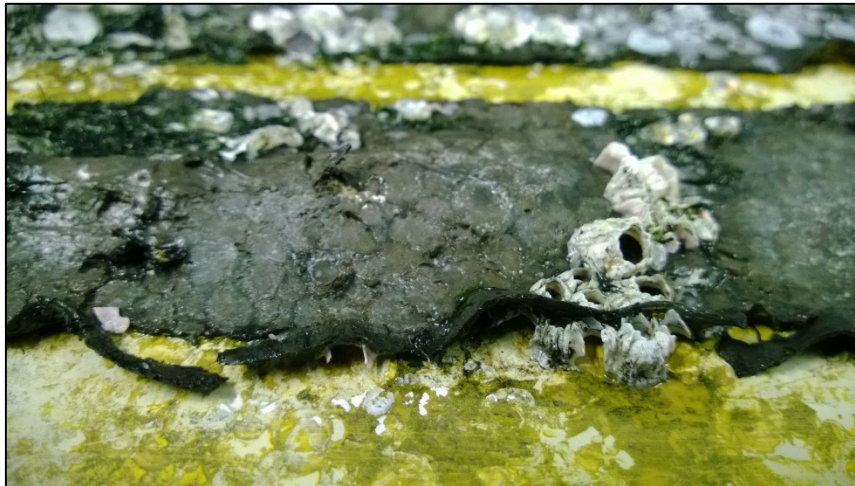
Fig. 5: Barnacles creeping under the protection layer of plate 37/38.

It was observed that plate 37/38 was severe attacked by barnacles. The black protection layer was wrecked and the barnacles were crawling beneath it, like shown in the picture beneath (Fig. 5).

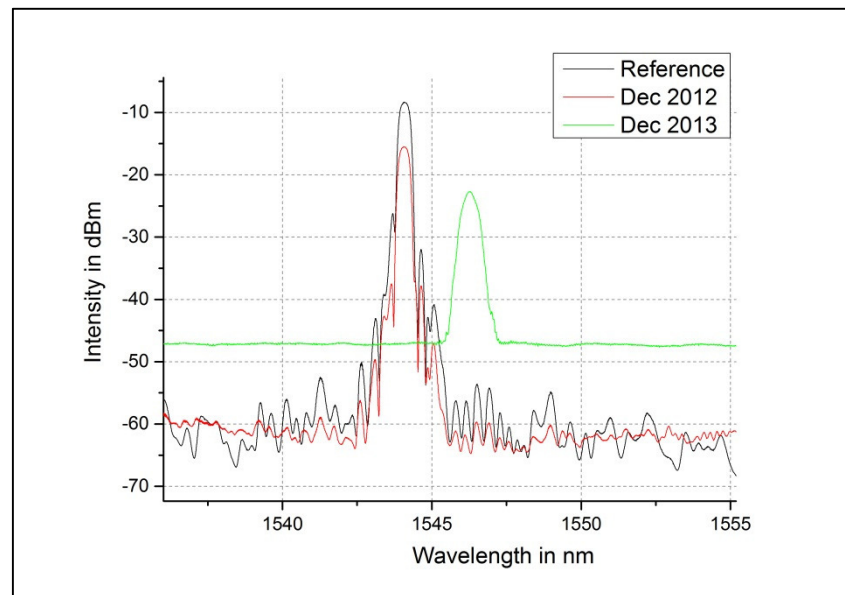
Measurement point 36:

A sensor signal can also be found at measurement point 36 and a spectral response signal was obtained from this sensor. The sensor signal shows a positive wavelength shift which indicates strain acting on the sensor. However, the intensity of the signal is very low at room temperature.
