Tunnel Deformation Monitoring

Project	Installation of OFS system to monitor the movements of a road tunnel during remedial grouting works
Client	Withheld
Date	2005
Location	Spain
Sensors	SmartRod
Attachment	Bolted to tunnel lining
Interrogator	W4
Images	<div style="display: flex; justify-content: space-around;"> <div style="text-align: center;">

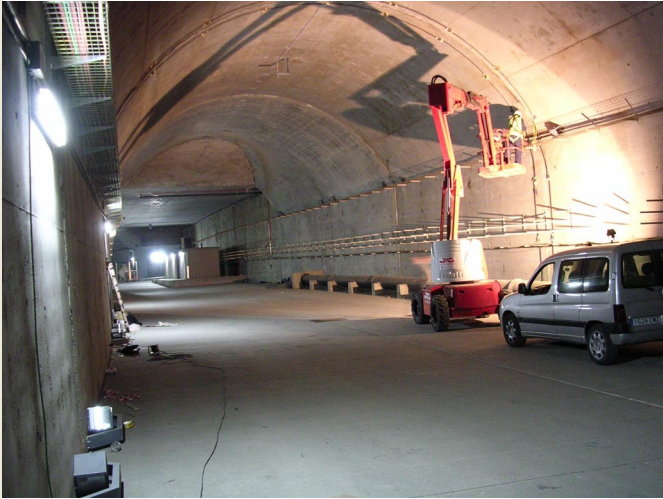
<p>SmartRod Installation</p> </div> <div style="text-align: center;">

The zone of the tunnel instrumented with SmartRod was constructed of concrete sections forming an arched roof with an apex approximately 7m above the floor and vertical sidewalls. Two SmartRod sensors were applied, one either side of a joint between sections, each SmartRod containing two channels of multiple Fibre Bragg Grating strain sensors. The rods were fixed to the tunnel wall using rigid clamping plates that ensured no relative movement between adjacent rods – the rod and clamp system extended less than 50mm from the tunnel wall surface. The system was installed using a small ‘cherry picker’ by 2 persons over 2 days.

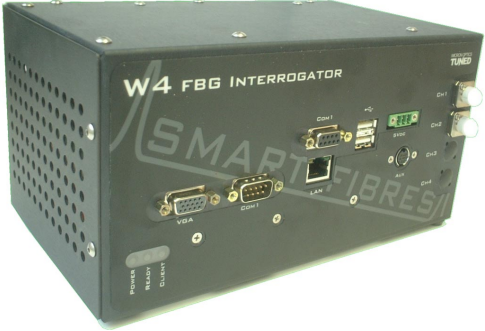
The Sensor responses were recorded and logged using a W4-5 (4-channel, 1 Hz) FBG Interrogator as the grouting machine advanced towards the instrumented zone, worked within the instrumented zone, and then moved away down the tunnel.

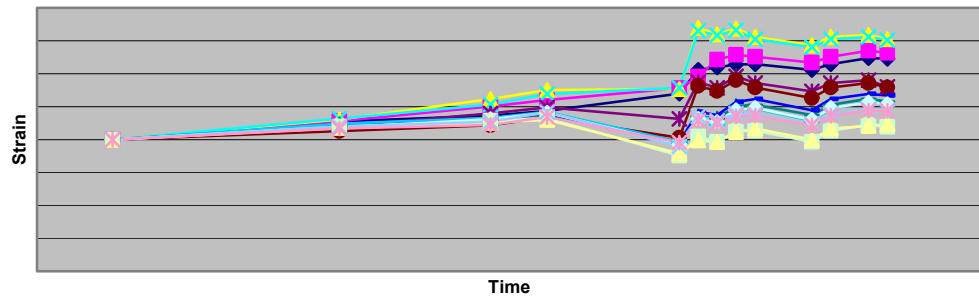
Typical Result (full data withheld)

The plot below shows typical measurements from the sensors of one SmartRod section as the grouting works slowly approaches the instrumented zone, then works within the instrumented zone, and then moves away.

Clearly visible, is the strain slowly building up as the grouting works approaches as the unstable, instrumented section deforms as a result of the works. Then, during the grouting of the actual section there is a significant, permanent strain change reflecting the compression of the tunnel by the grouting. After that, the strain is relatively stable as the machine moves on, suggesting that the instrumented zone is stable and unaffected by the ongoing works.

The typical strain measurements above suggest that the system is working as expected. At the time of writing, the strain data for the complete monitoring campaign is being converted to tunnel displacement data using the proprietary data manipulation routines developed by the OFSTUNN project partners. Further information is not currently available.
