Towards development of a fiber optic-based transmission monitoring system

Chris S. Baldwin^{*a}, Jason S. Kiddy^a, Paul D. Samuel^b

^aAither Engineering, 4865 Walden Lane, Lanham, MD USA 20706

^bDaedalus Flight Systems, 8945 N. Westland Dr., Suite 302
Gaithersburg, MD 20877

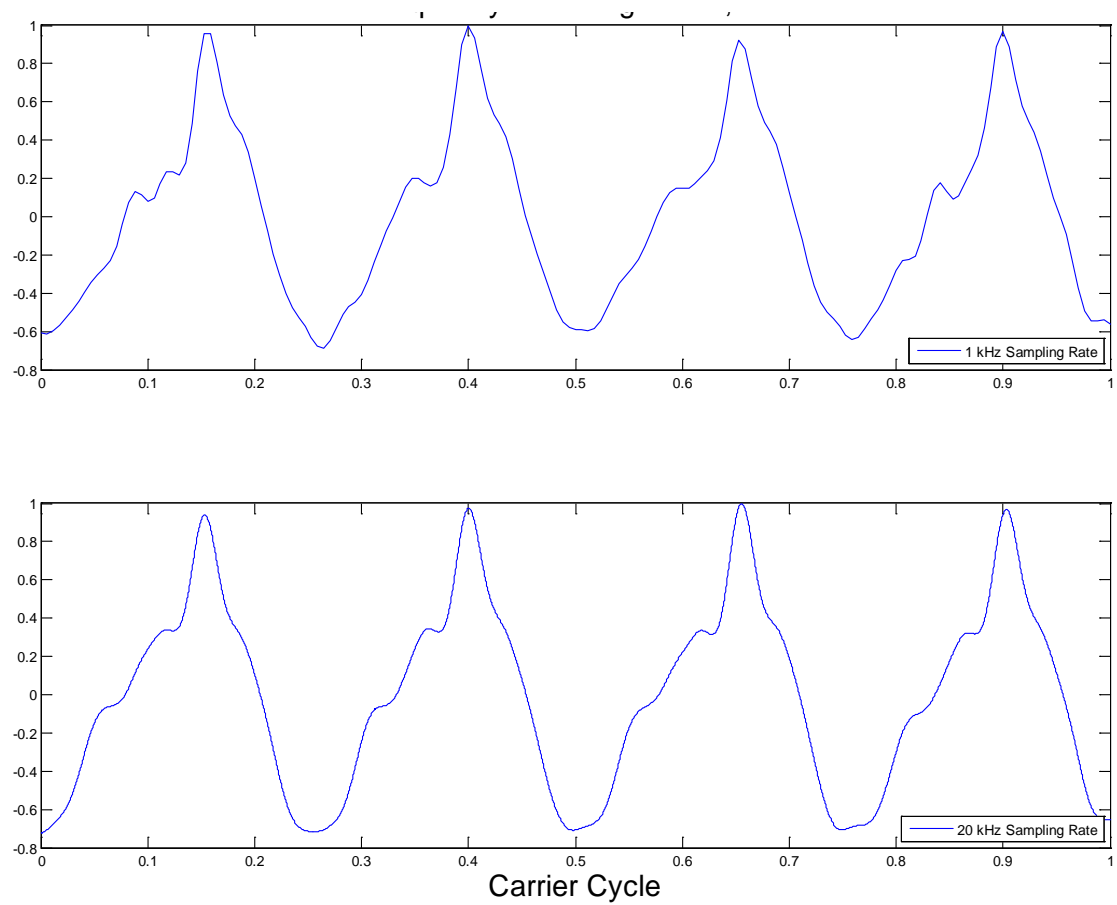
Figure 5: Low frequency component of data collected over 1 carrier rotation: 1 kHz sampling rate (top) and 20 kHz sampling rate (bottom)

Figure 3 presents a comparison of one carrier cycle of raw, unaveraged normal RPM data collected at 1 kHz and at 20 kHz. Figure 4 shows the high frequency components of the signals, and Figure 5 shows the low frequency components of the signals. The fiber optic strain signals contain both a high frequency component associated with tooth mesh deformations as well as a low frequency component associated with the deformation of the ring gear.

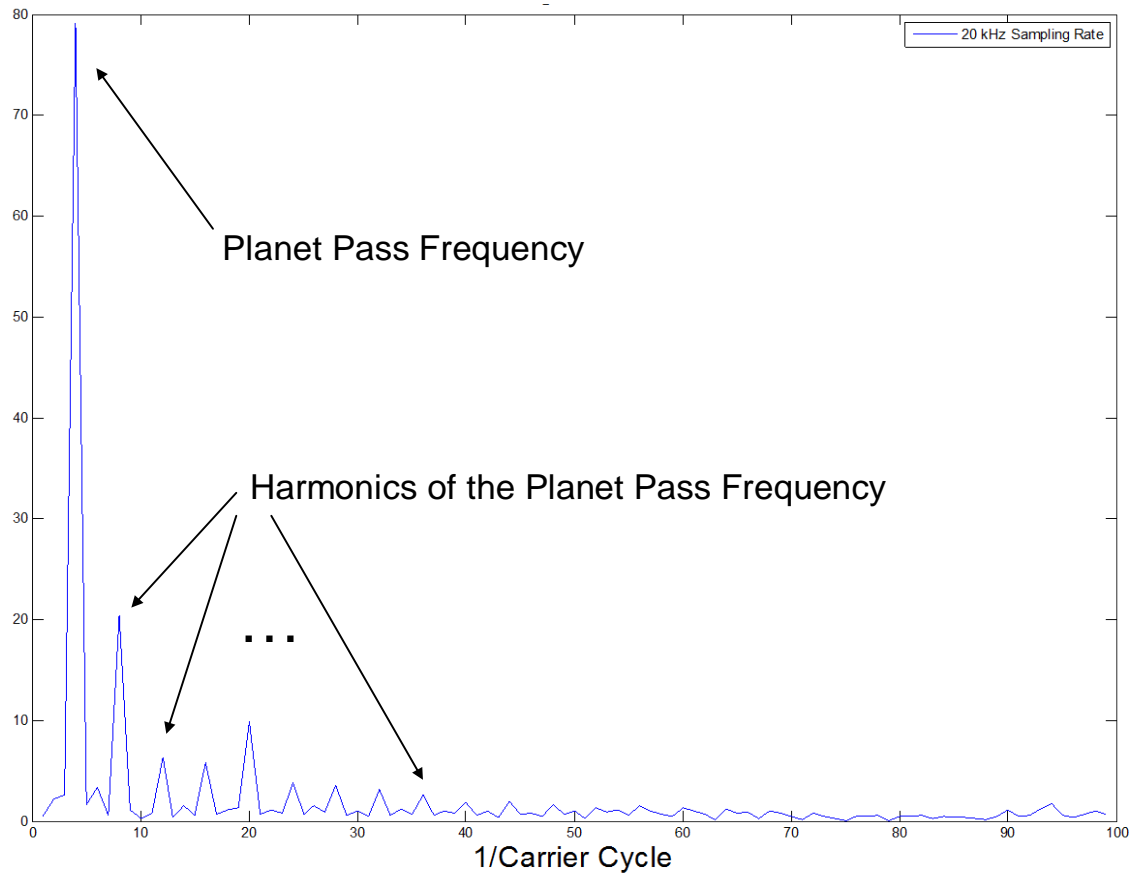
Figure 6: Spectrum of raw data collected sampled at 20 kHz. Low frequency range highlighted to show planet pass frequency.

The spectrum of the high sampling rate signal is shown in Figure 6 and Figure 7. Figure 6 presents the low frequency range of the raw data, and clearly shows that the planet pass frequency and harmonics are still easily captured. Figure 7 presents the spectrum of the high frequency component of the signal, and once again shows that good separation is achieved between the low and high frequency signals. In addition, it is evident that multiple harmonics of the mesh frequency are clearly captured. Finally, Figure 8 presents a comparison of the spectra of the high frequency components of the 1 kHz and 20 kHz data. This figure clearly indicates that an increase in the sampling rate enables the fiber optic strain sensors to clearly capture high frequency features of the vibration signal, and would make damage detection at the normal operating RPM possible since the mesh frequency is now captured.

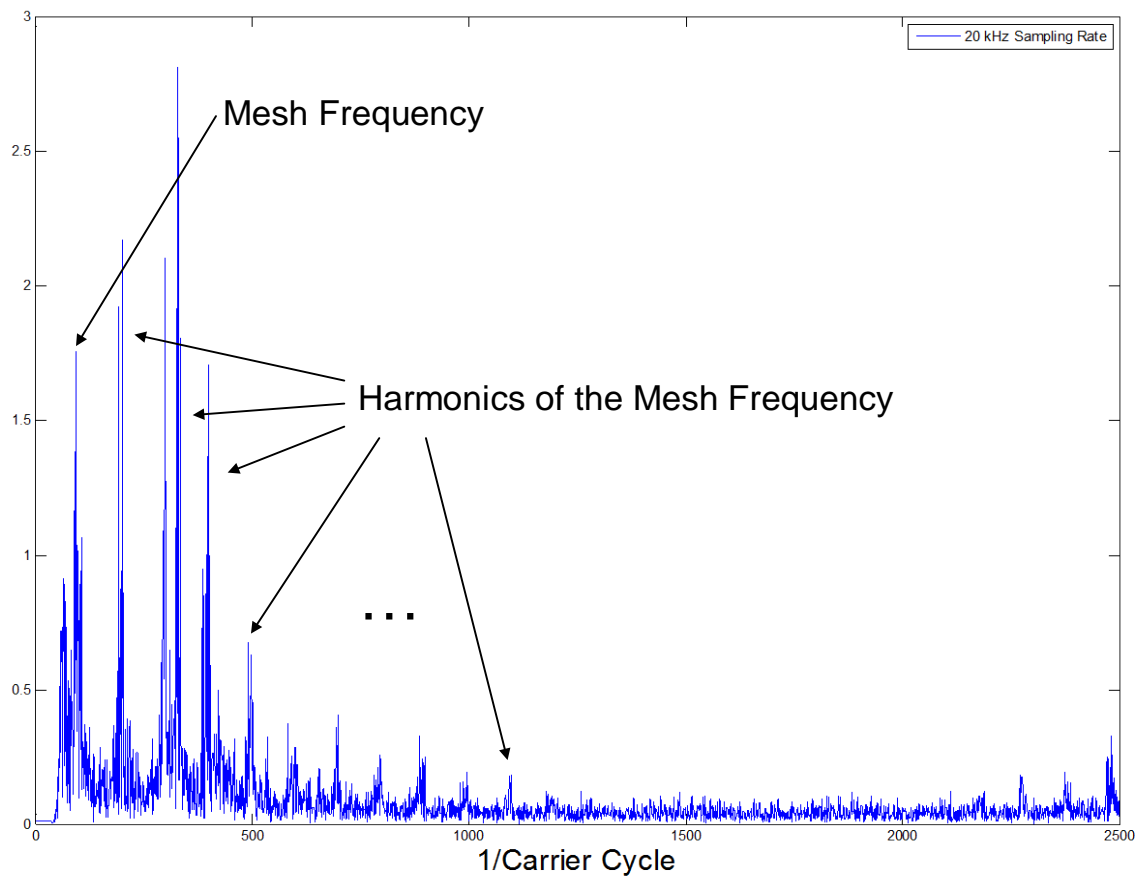
Figure 7: Spectrum of high frequency component of data sampled at 20 kHz.

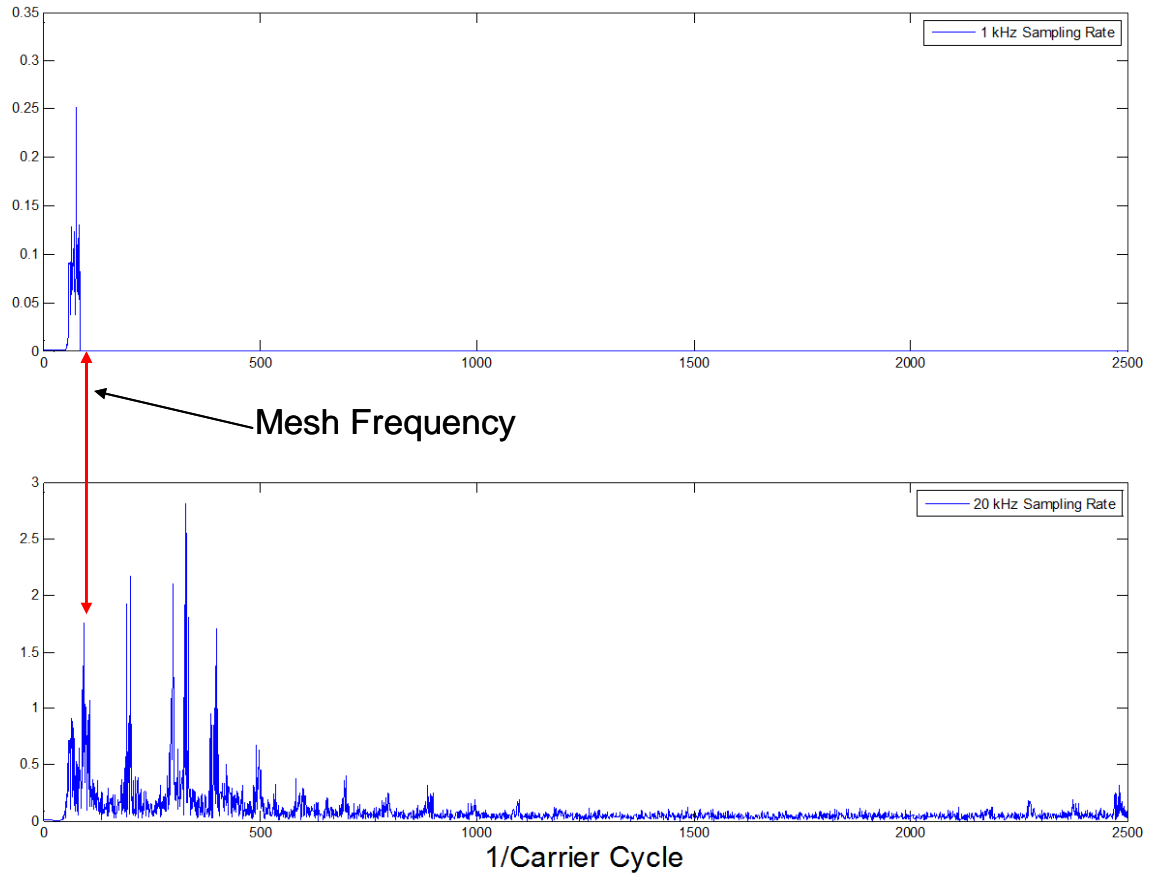
Figure 8: Comparison of spectra of high frequency component of data sampled at 1 kHz (top) and 20 kHz (bottom)

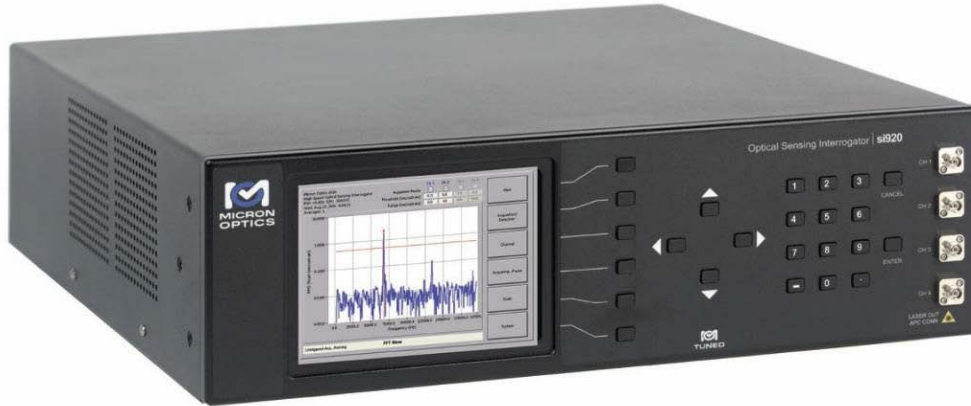
Figure 9: Micron Optics' si920 Instrumentation System [8]

The Micron Optics' si920 has the highest sampling rate of any of the interrogators at 500 kHz [8]. However, this high sampling rate is only available for a single FBG sensor per fiber. The unit has four optical channels and can interrogate all four simultaneously (four total FBG sensors) at a rate of 100 kHz. This unit would provide a more than adequate sampling rate for the monitoring system, but the requirement for each FBG sensor to be dedicated to a single optical fiber would lead to a very difficult egress from the transmission housing.

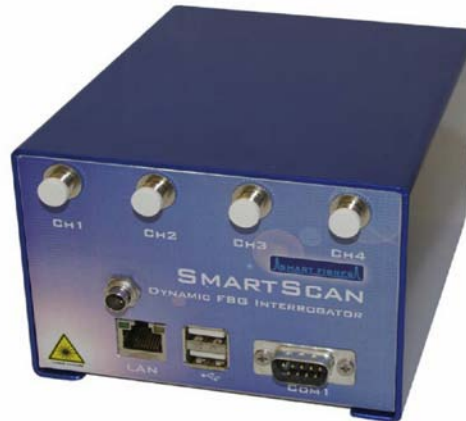
Figure 10: Smart Fibres' SmartScan Interrogator [9]

The Smart Fibres SmartScan Dynamic FBG Interrogator allows for a user defined sampling rate that is dependent on the optical bandwidth selected by the user. The default setting on the SmartScan instrument is to have an optical bandwidth of 40 nm (maximum for the unit) resulting in a sampling rate of 2.5 kHz [9]. With a 40 nm optical bandwidth, a total of ten FBG sensors could be serially multiplexed for the ring gear application. The interesting attribute of the SmartScan system is the ability to change the optical bandwidth and increase the sampling rate of the system. Changing the optical bandwidth is performed on all four optical channels of the SmartScan system, so all FBG sensors must fall within the user selected bandwidth. During testing with the current research effort, a 20 kHz sampling rate was used. However, the optical bandwidth was reduced to the point where only two FBG sensors could be interrogated.

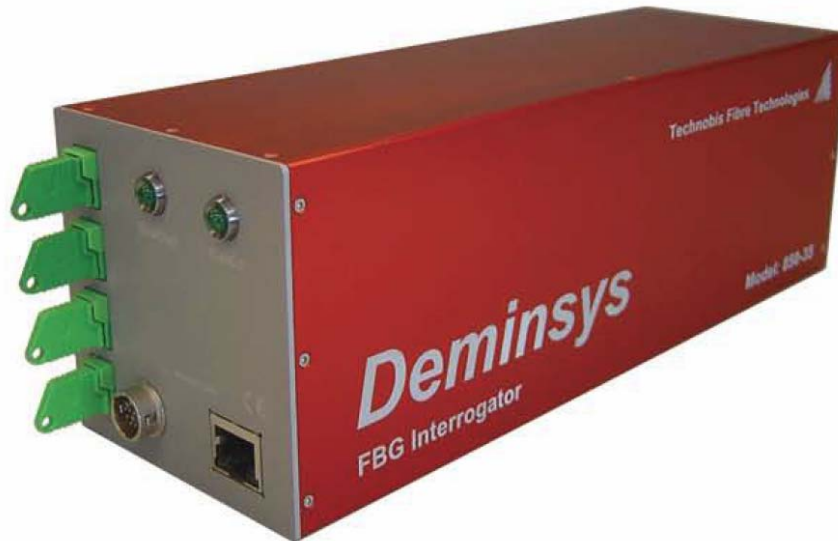
Figure 11: Technobis Fibre Technologies' Deminsys FBG Interrogator [10]

Technobis Fibre Technologies Deminsys FBG interrogator utilizes a CCD imager to capture the reflected FBG signals [10]. The imager is sensitive to light at a different wavelength than the other interrogators discussed. The wavelength range for this unit is 830 to 870 nm (40 nm optical bandwidth). The other interrogators operate in the 1550 nm range. The system currently relies on the FBG sensors having certain wavelength values so the interrogator software knows where to bin the corresponding pixels on the imager. The interrogator is currently limited to 8 serially multiplexed FBG sensors per channel with a sampling rate of 20 kHz.
