DOCUMENT IDENTIFIER: TSN170/131081
SUBJECT:

**ENVIRONMENTAL TEST REPORT
ON
SMART FIBRES SMARTSCAN AERO INTEROGATOR UNIT**

DOC ID: TSN170/131081

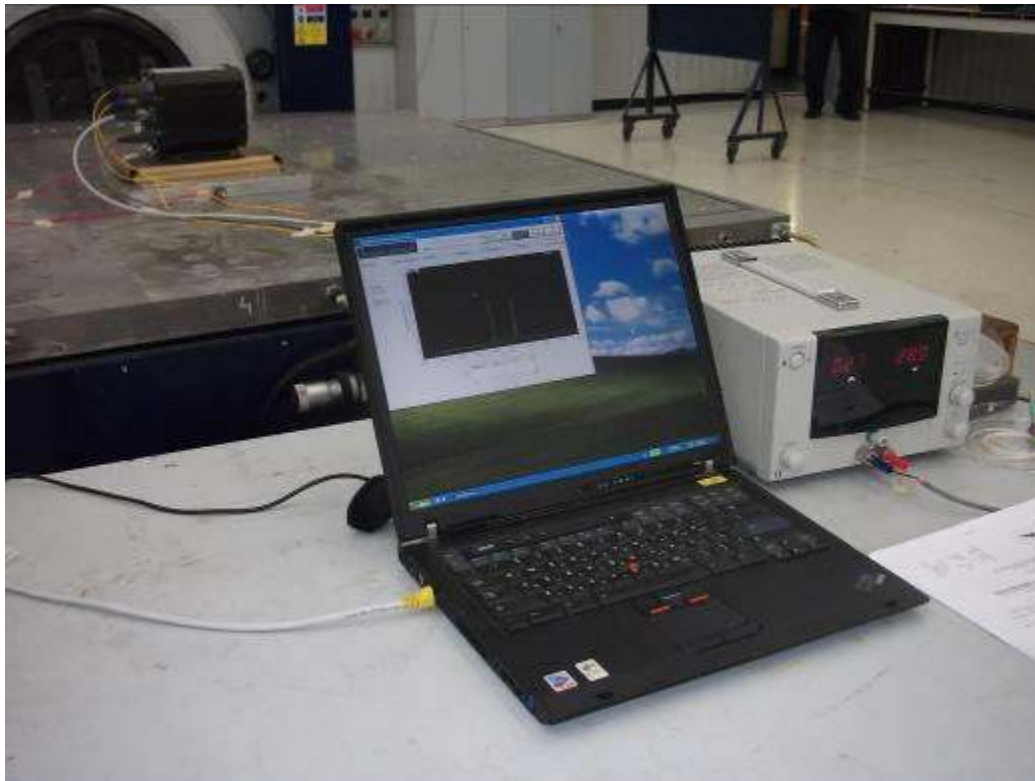
Photograph 2: Vibration and Shock Test setup – Y Axis
Data recording of two channels

- 5.2.1 The UUT was fastened to the test fixture by its normal mounting means, which was in turn secured to the Vibration Shaker. The vibration and shock input was measured by an accelerometer mounted on the fixture close as possible to the test item . The test setup is shown in Photographs 1 to 3.
- 5.2.2 Random Vibration, along 3 axes, in accordance with MIL-STD-810F, Method 514.5, Procedure I, over the appropriate frequency range of 5-2000 Hz for period of 4 hours per axis was applied, according to the random profile per Figure 1.
- 5.2.3 The shock test along 3 axes in accordance with MIL-STD-810F, Method 516.5, Procedure I, Figure 516.5 – 10 (Saw Tooth), 20g Peak Value and 11msec duration.
- 5.2.4 Operational checkout was performed both during and at the conclusion of each test.

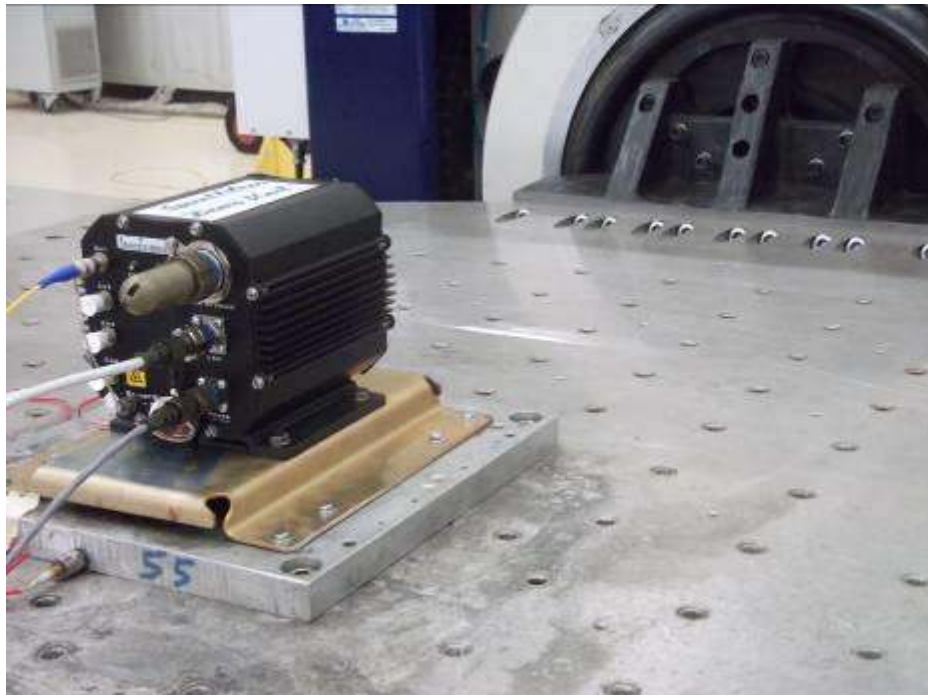
Photograph 3: Vibration and Shock Test setup – X Axis

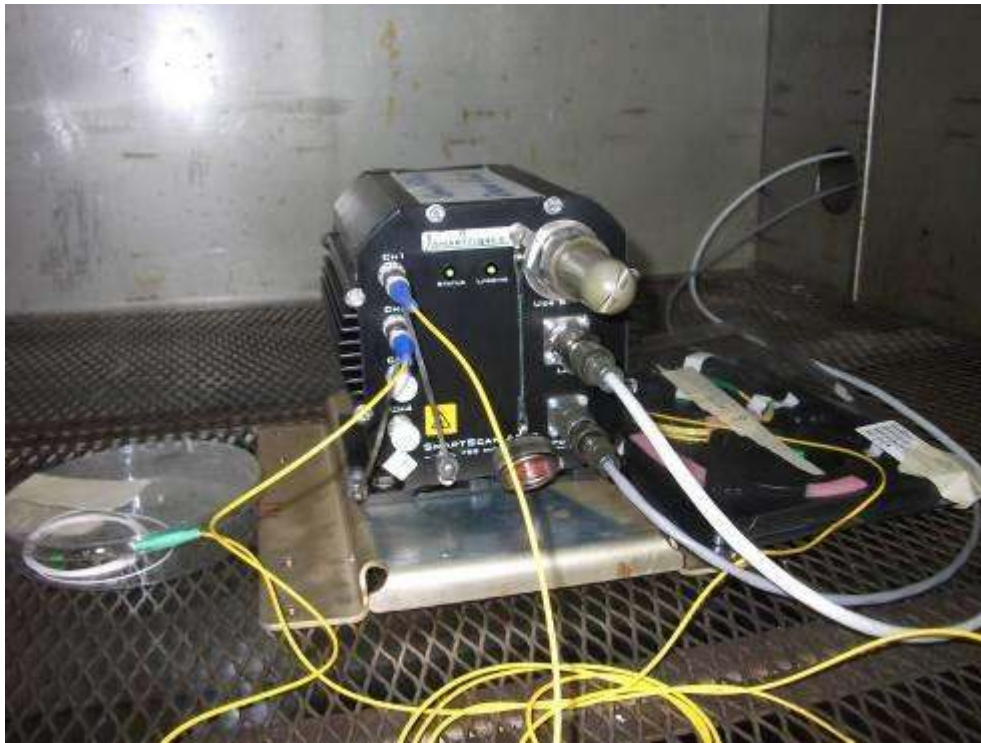
Photograph 4: Temperature - Altitude Test setup
Date recording of two channels by USB disk

The test setup is shown in Photograph 4.

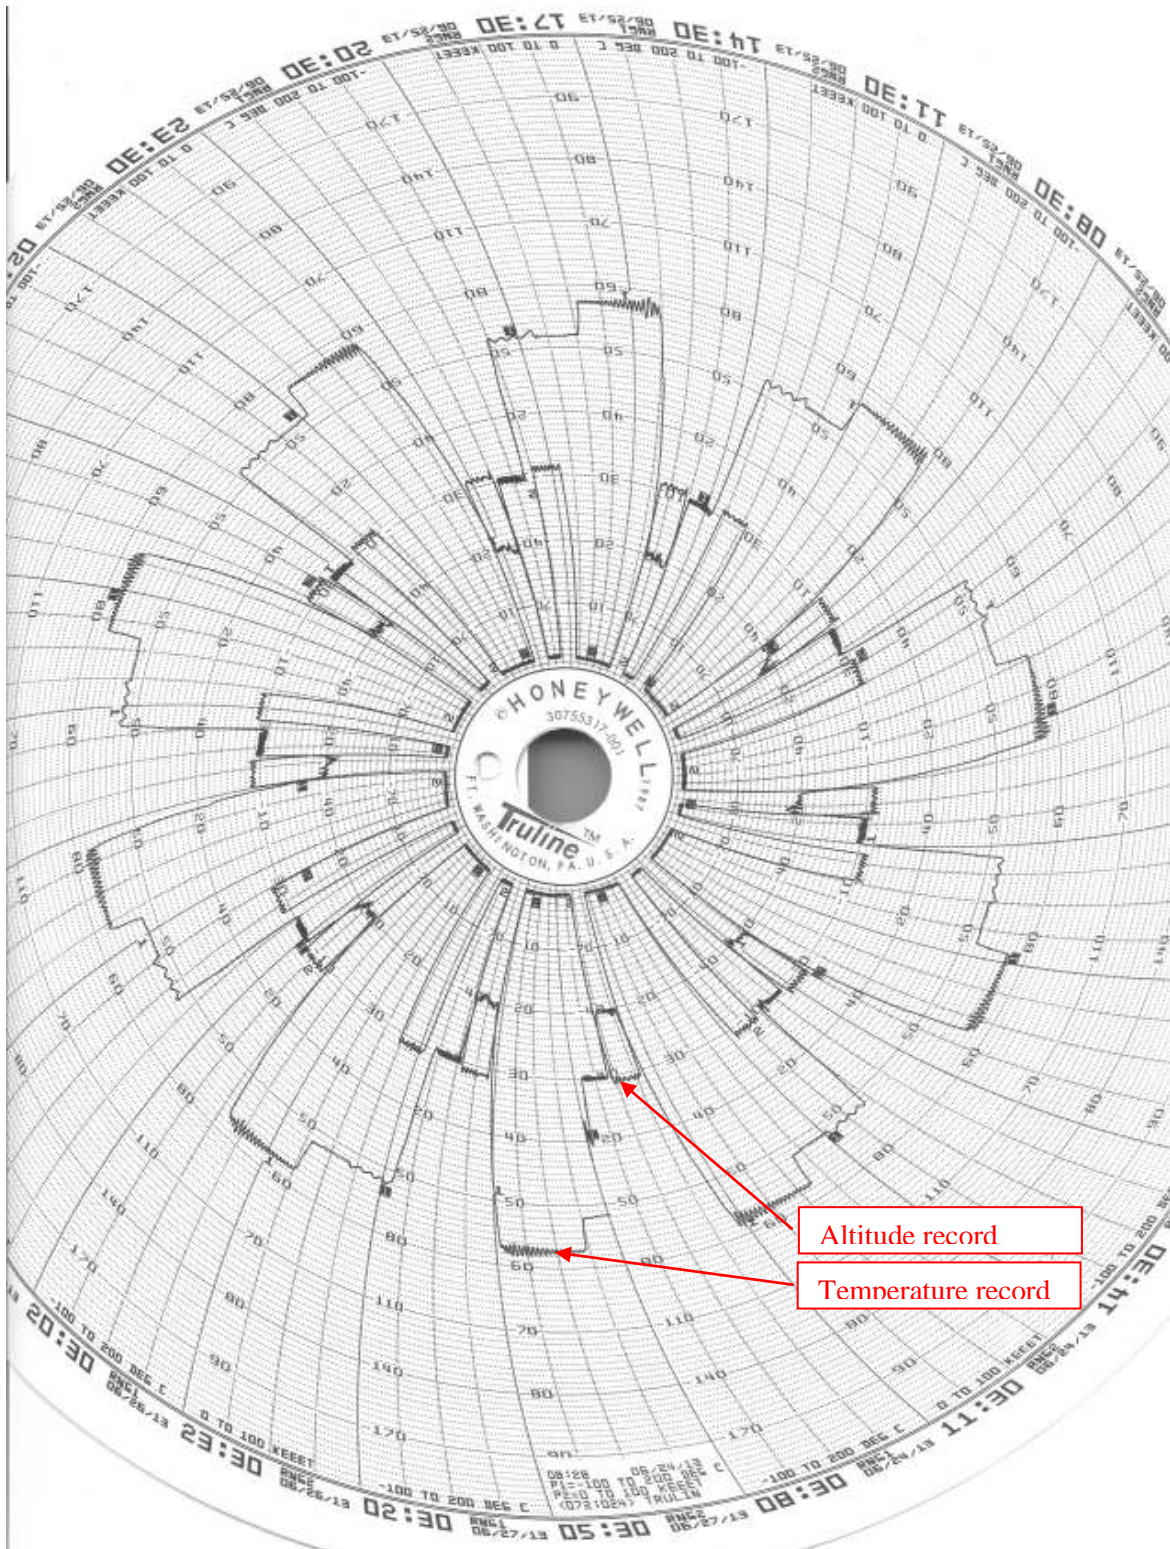
Figure 3 : Temperature-Altitude Test Record (Phase I)

6.3.1 The test records of the temperature-altitude cycles are presented in Figures 3 and 4.

No.	Temperature (°C)	Altitude (ft)	Time after Stabilization (hr)	System Operation
1	-10	0	1	On
2	-40	30,000	1	On
3	71	0	2	Off
4	55	0	1	On
5	55	30,000	1	On

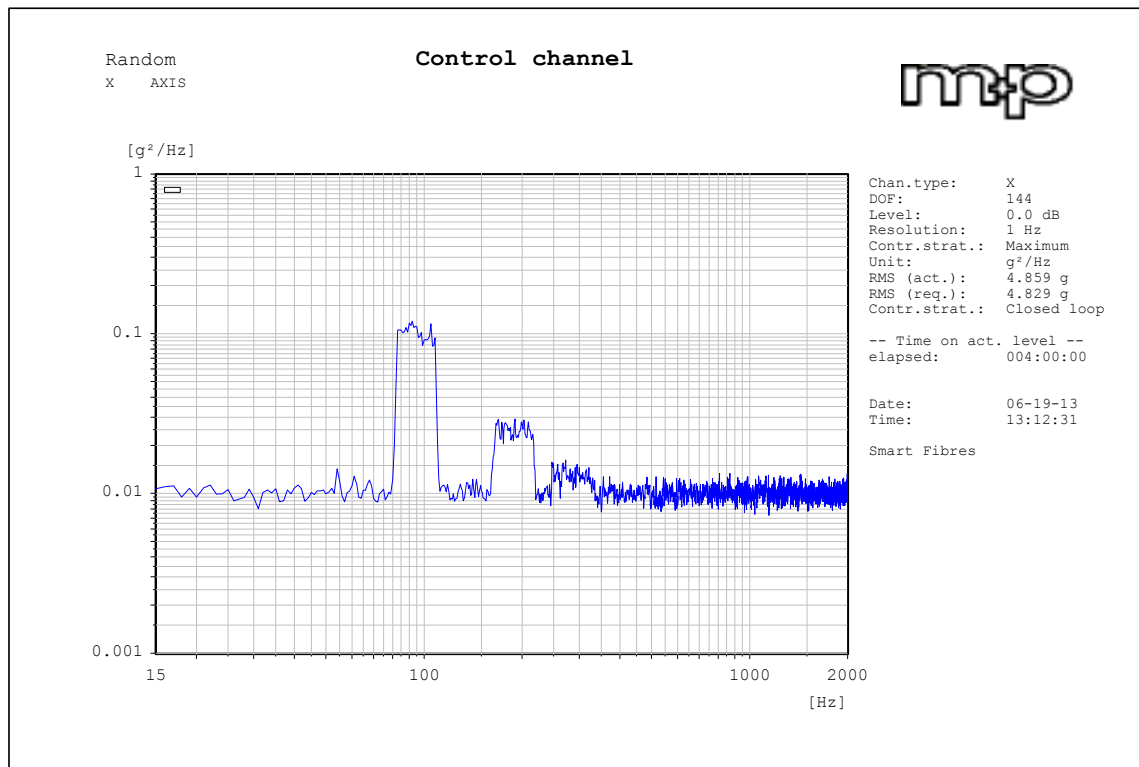
Figure 5: Random Test record –X Axis

- 5.3.1 Test records of the vibration and shocks tests are shown in Figures 5 to 13.
- 5.3.2 The visual examination of the external surfaces of the test items, at the conclusion of the tests, revealed no apparent damage as a result of these tests.
- 5.3.3 The UUT successfully passed the vibration and shock test conditions.

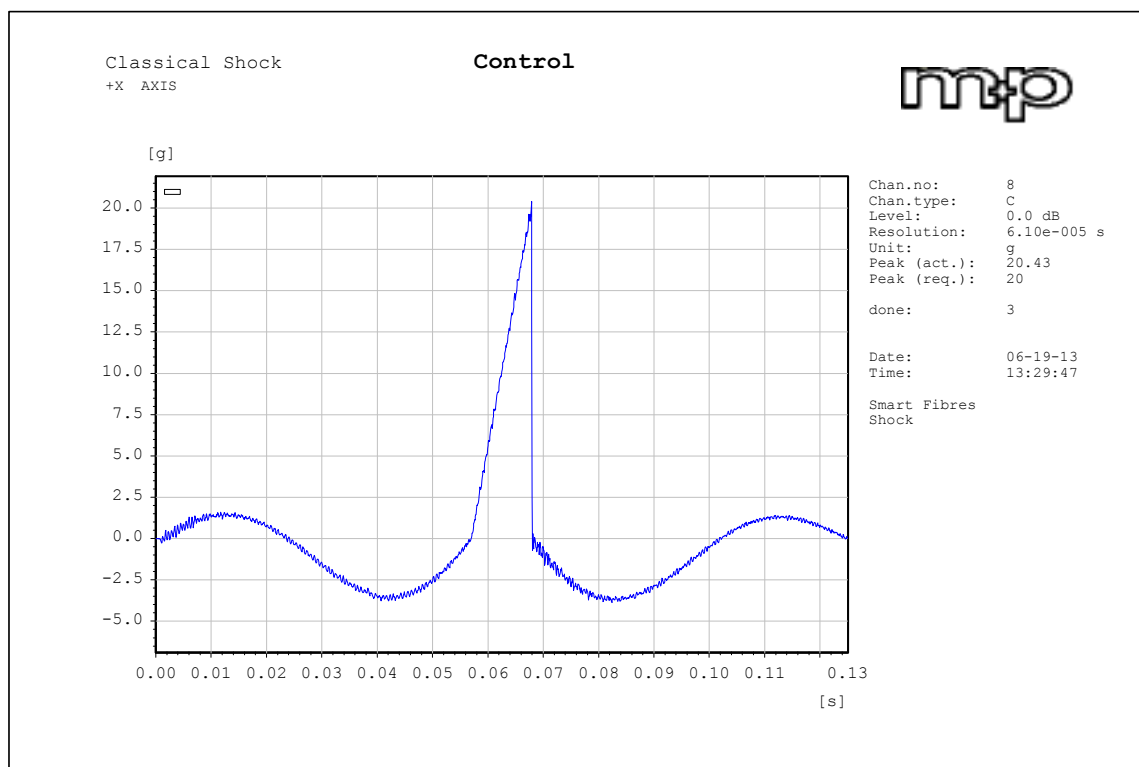
Figure 6: Shock Test record –X Axis-Positive

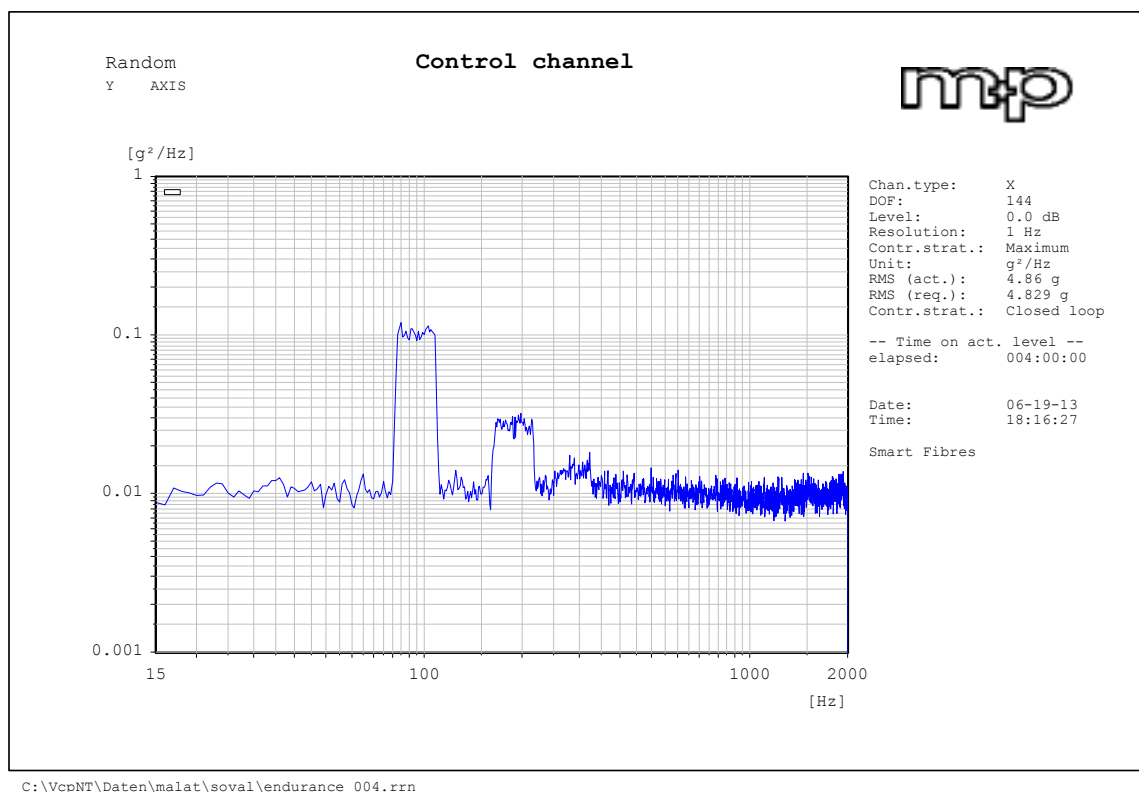
Figure 8: Random Test record -Y Axis

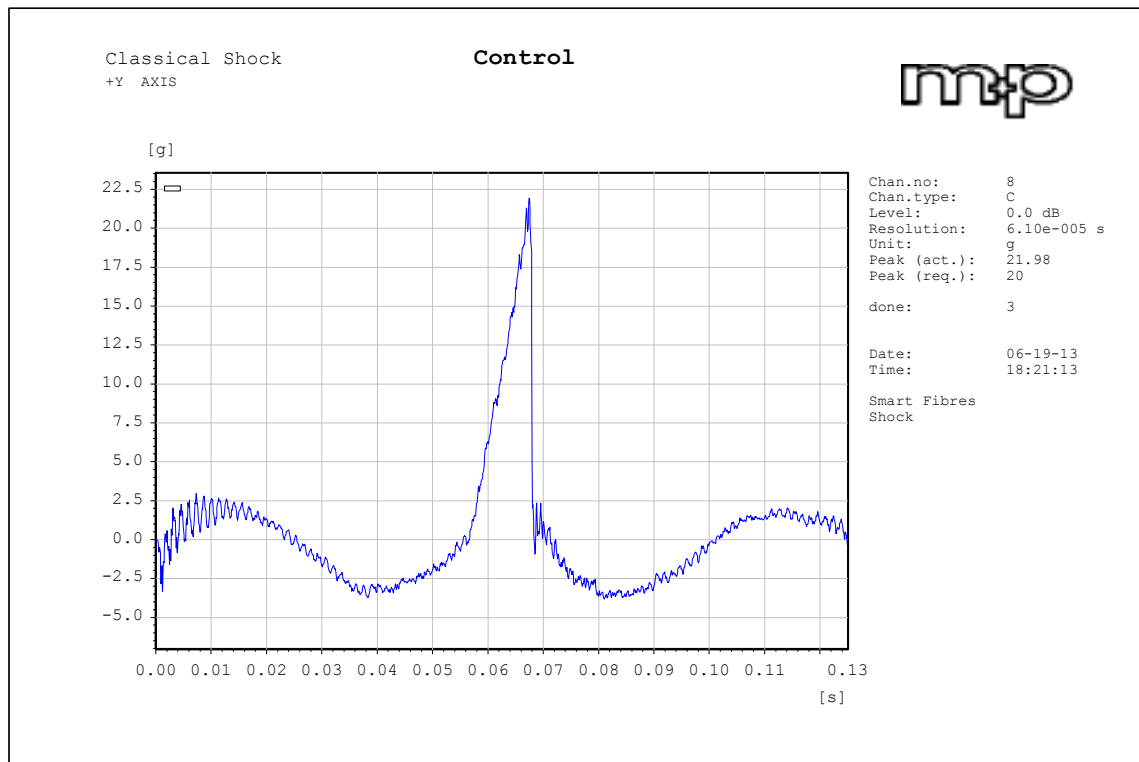
Figure 9: Shock Test record –Y Axis-Positive

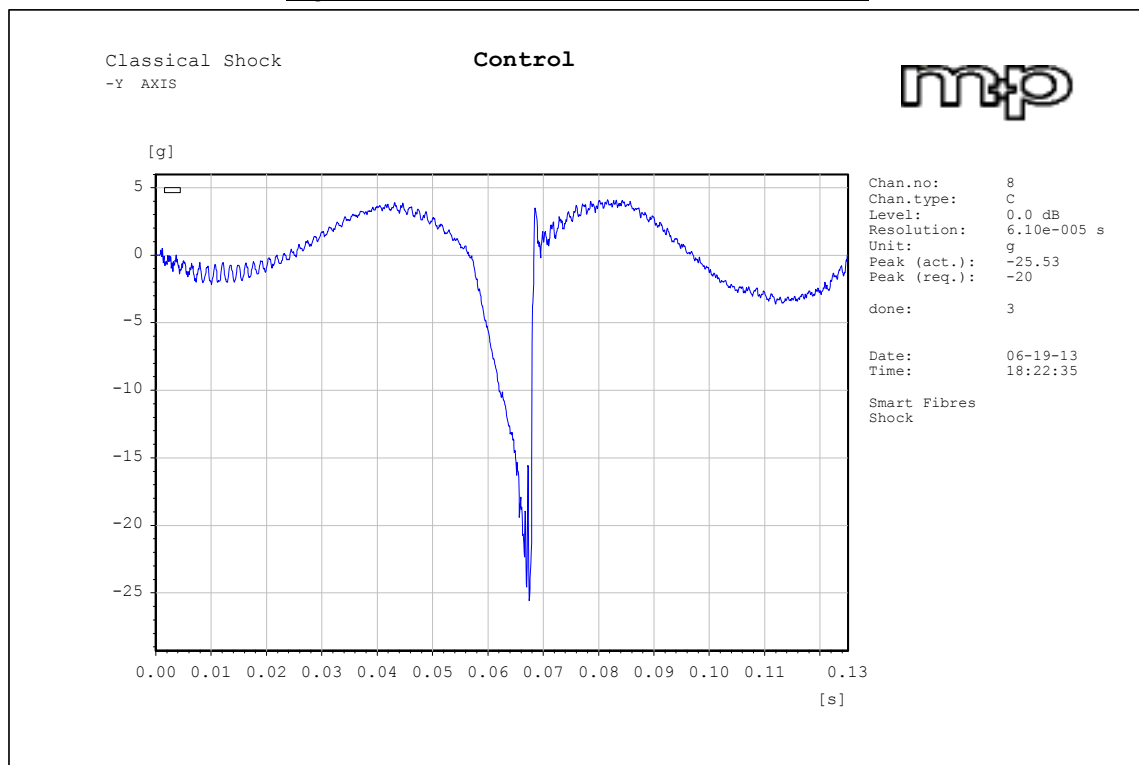
Figure 10: Shock Test record –Y Axis-Negative

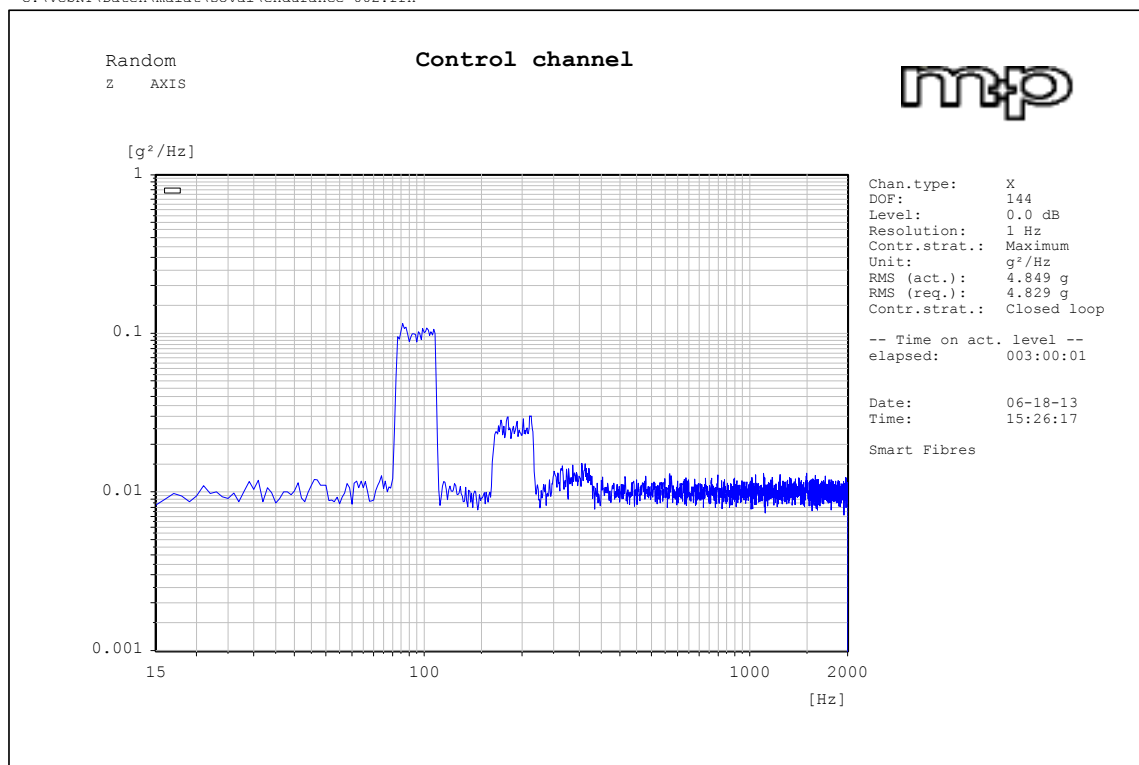
Figure 11: Random Test record –Z Axis
