# Case Study: Subsea pump Pump Condition Monitoring

Partners: Smart Fibres, Flowserve, SKF, Teledyne ODI  
Project Sponsor: Shell Upstream Americas – Deepwater

Platform: Subsea twin-screw pump and motor  
Objective: Develop fibre optic condition monitoring  
Why fibre: Harsh environment, no subsea electronics

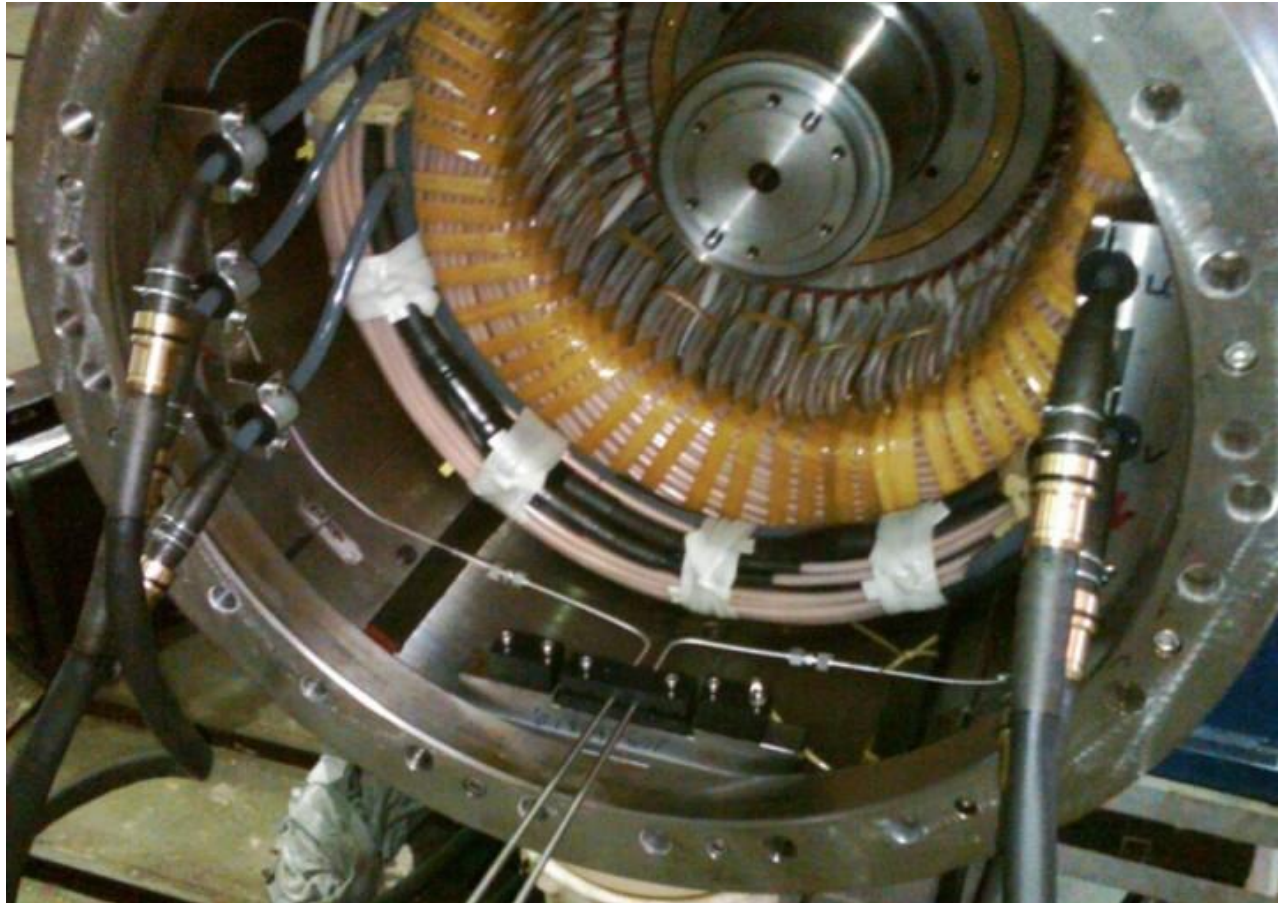
18 motor temperature sensors

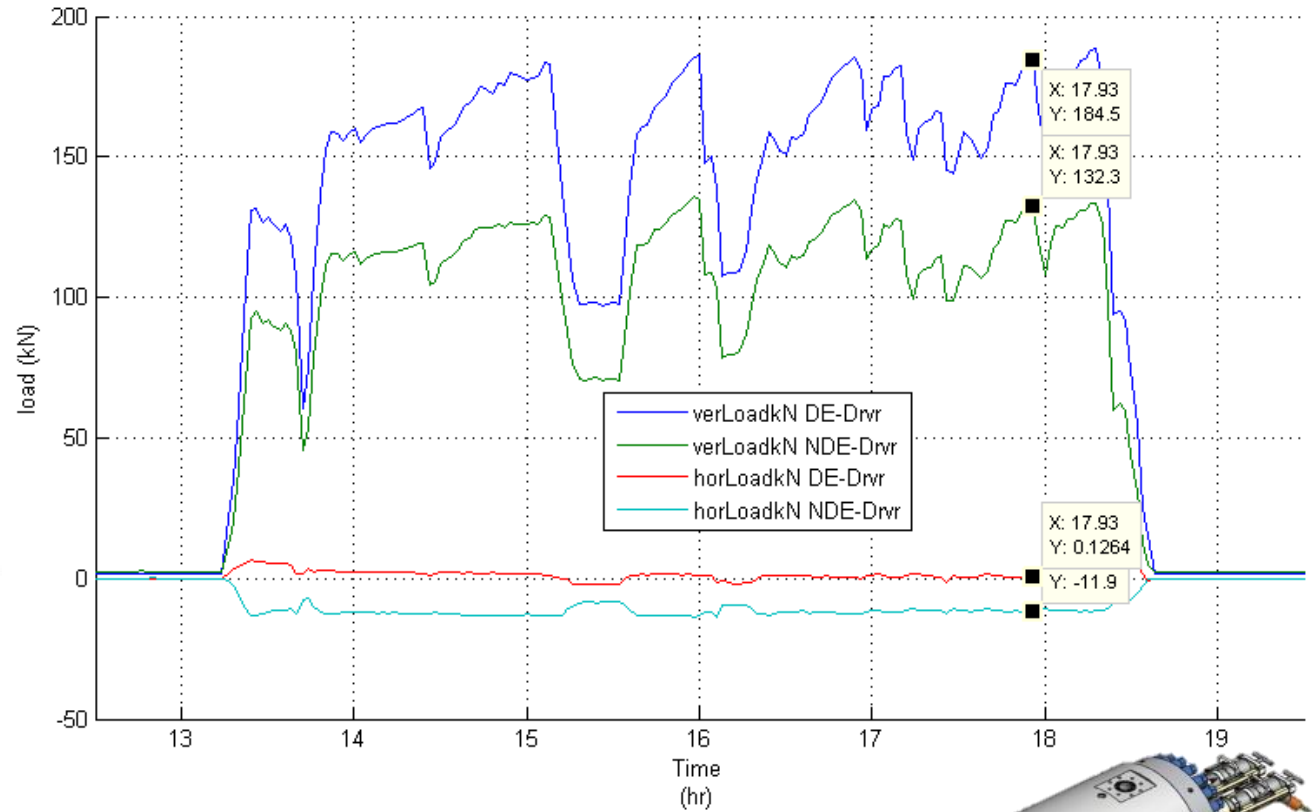
Bearing loads match FE model within 5%

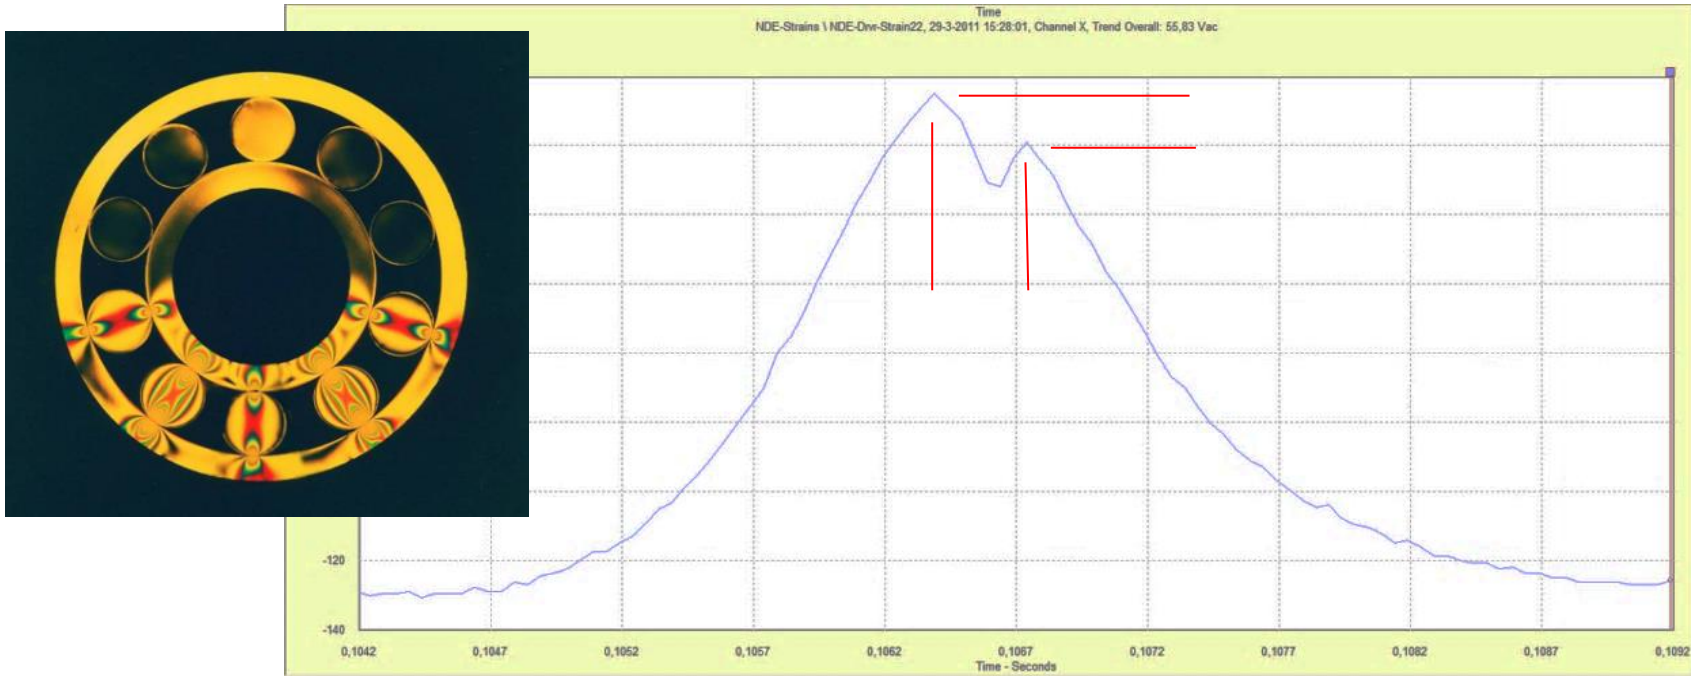
Data analysis predicted:  
 3.0 mm scratch length,  
 minimal scratch depth

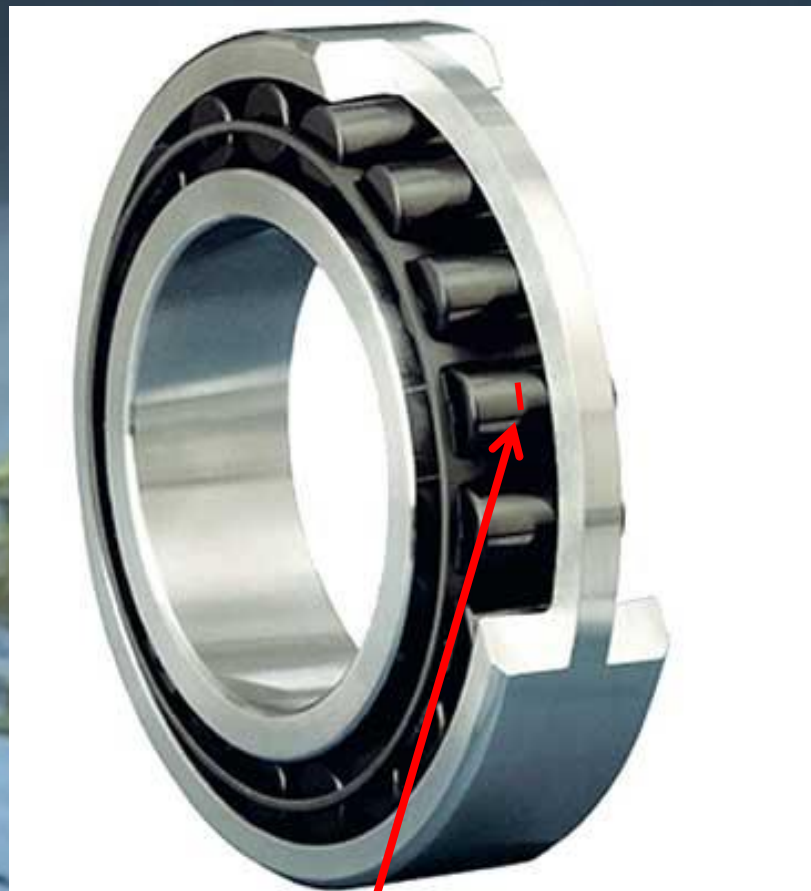
A 2 micron scratch here
