BAM Information Summary

Seaside Exposure of Sensor Samples in the North Sea

within the research project “Development of standards for fibre optic sensors under offshore-typical conditions” (BAM-VH 8138)

Report period: June 2012 to November 2013

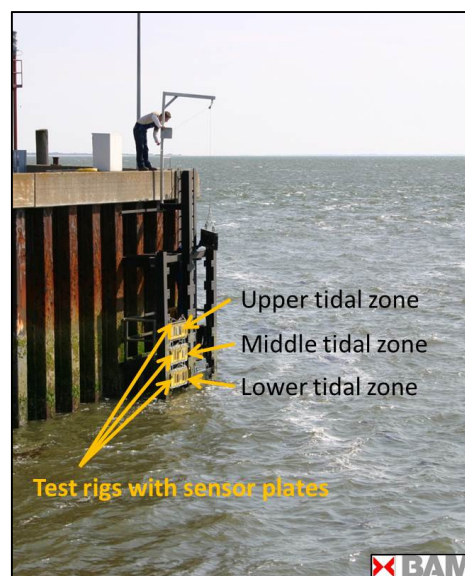
Fig. 1: Set-up of the test rigs with sensor plates in the three tidal zones

All fibre optic cables connected to the sensor installations have been fixed with a protective coating to the plates by BAM. On June 21st 2012, the plates have been exposed to the North Sea tidal water zone in test rigs at the German island Sylt. The tidal water zone consists of a lower zone where one rig with plates is most of the time exposed to sea water, a second (middle) zone with a rig of plates that is in the mean exposed to sea water and surrounding air and a third (upper) zone with a rig of plates that is only exposed to sea water during flood, as can be observed in Fig. 1. Plate 33/34 was located in the middle zone, plate 35/36 was located in the upper zone and plate 37/38 was located in the lower zone. Fig. 2 shows exemplarily one of the three test rigs.
