## HIGH SPEED, IN-FLIGHT STRUCTURAL HEALTH MONITORING SYSTEM FOR MEDIUM ALTITUDE LONG ENDURANCE UNMANNED AIR VEHICLE

### ABSTRACT

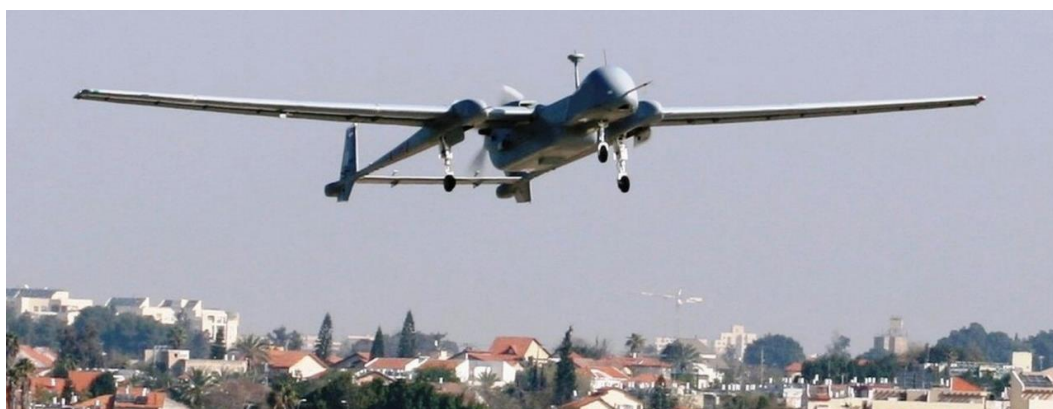
Figure 1: One of IAI's UAVs after takeoff. In the current project two fibers were embedded on each boom and wing, see Fig. 2 for details

MALE UAV (Figure 1), designed and manufactured in Israel by Israel Aerospace Industries was selected by the Israeli Air Force as the test-bed for the evaluation of this fiber-optic based HUMS concept in operational real-field environment. Each of the two tail booms is a composite beam

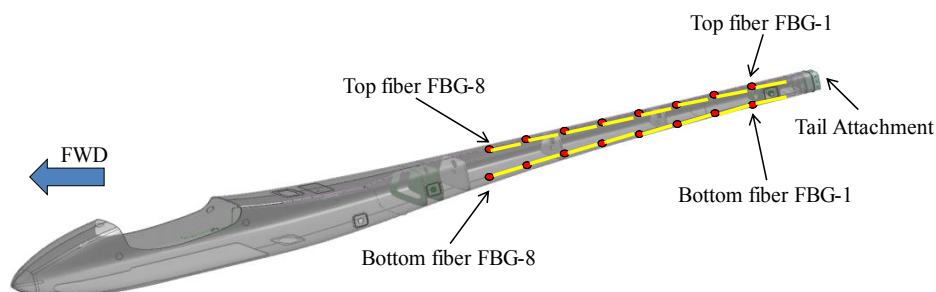
Figure 2: Boom general layout and the routing of the embedded optical fibers in the boom. 16 FBGs were located at points of interest (RHS boom shown. LHS is similar.)

Each boom is basically a cantilever beam with a relatively large mass at the back end. The main boom loading condition is vertical bending. In order to track these loading conditions, two fibers were embedded at the center of the boom ("Top" and "Bottom" in Figure 2). Eight FBG sensors were imprinted on each fiber. Thus, eight section of the boom are monitored by two FBGs; one on top and another on the bottom (Figure 2). For such a sensing net arrangement, the two fibers are only sensitive to vertical bending. Since the cross-section of the boom is not symmetrical with respect to the horizontal plane, vertical bending will introduce non-identical but opposite strains in corresponding top and bottom FBGs.

The first flight with the system fully operational was on October 2013. Typical FBG readings of boom mounted FBG (Top and bottom FBG-8, see Figure 2) is seen in Figure 5. The effect of engine start, takeoff, touch and go landing, acceleration to maximum speed and landing are clearly depicted by the FBG sensors. The effect of temperature is also seen as the UAV climbs to high altitude.

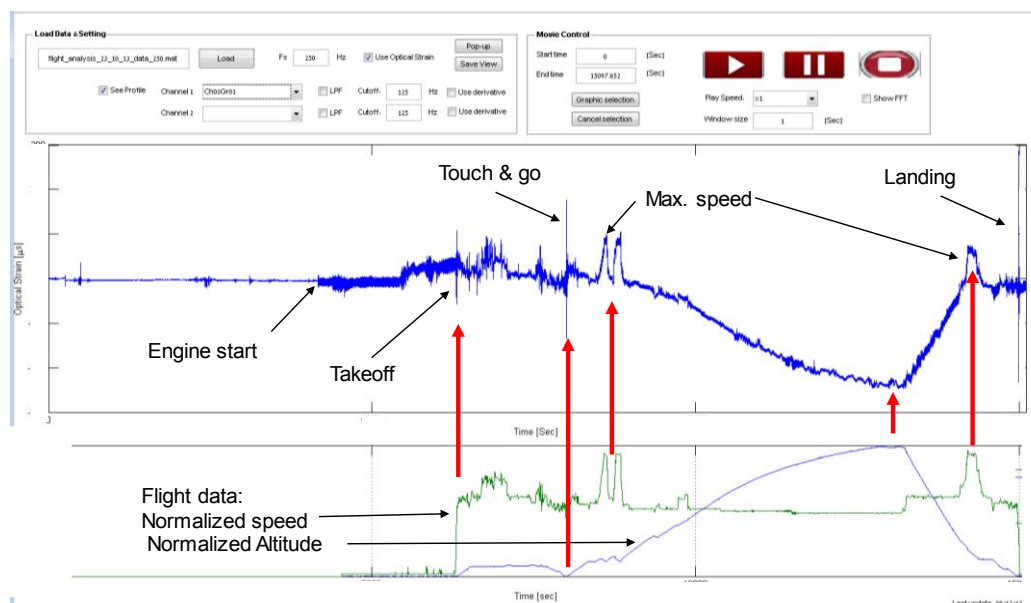
Figure 3: Flight data GUI; Typical Boom FBG readings during flight. Note the 'touch & go', maneuver and landing

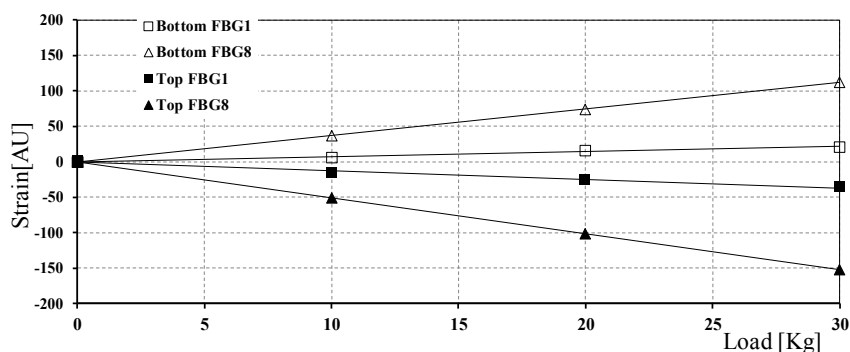
Figure 4: Typical Boom FBG calibration. At identical boom stations, top and bottom FBGs will have different strain magnitude

Static calibration tests were performed in order to correlate the embedded FBG readings with the boom loading under vertical bending load. Tail loadings were applied at the boom end near the tail, up to 30Kg. FBG readings were taken at 10Kg increments. Typical calibration results are presented in Figure 4, demonstrating the linearity of the FBG readings with respect to the applied load as expected.

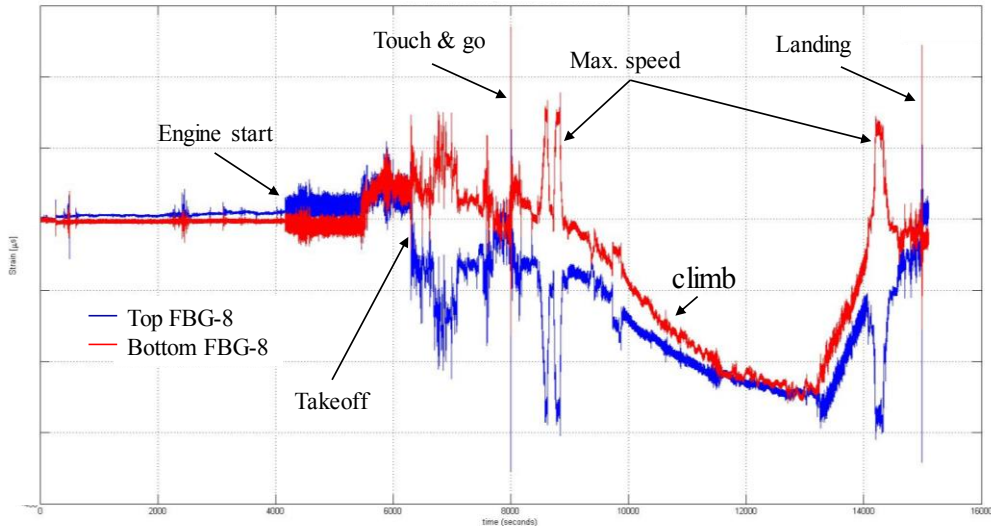
Figure 5: Typical FBG readings of boom mounted FBG (Top and bottom sensors)

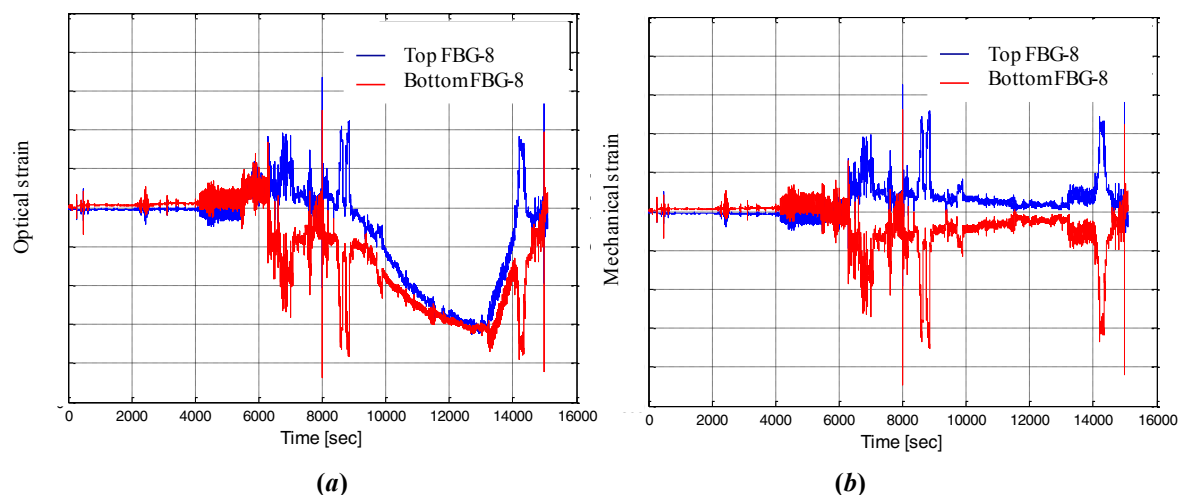
Figure 6: Boom FBG calibration. (a) Original FBG optical strain data. (b) Mechanical strain

By using Equation 1, the mechanical bending moment can be calculated and the individual mechanical strain at each sensor pair can be derived, as can be seen in Figure 6.

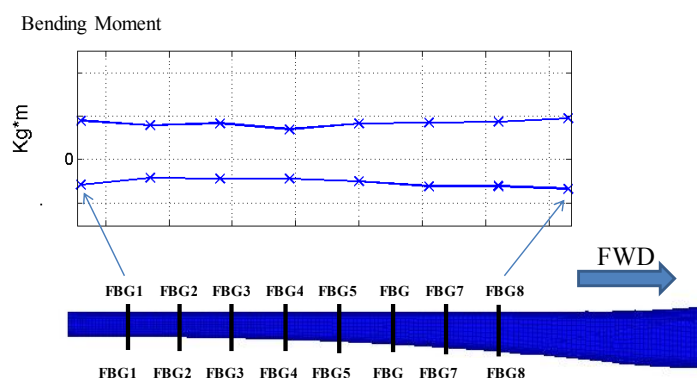
Figure 7: Boom bending moment envelope during landing

Typical boom bending moments derived from a specific landing are presented in Figure 7. The almost constant distribution of the bending moment along the boom indicates a complex loading condition, associated to its dynamic behavior.
